TECHNICAL SERVICE BULLETIN

XL/XLT - Instrument Panel Warped/Separated At Defrost Vents

19-2041
15 February
2019

Ford 2015-2019 F-150

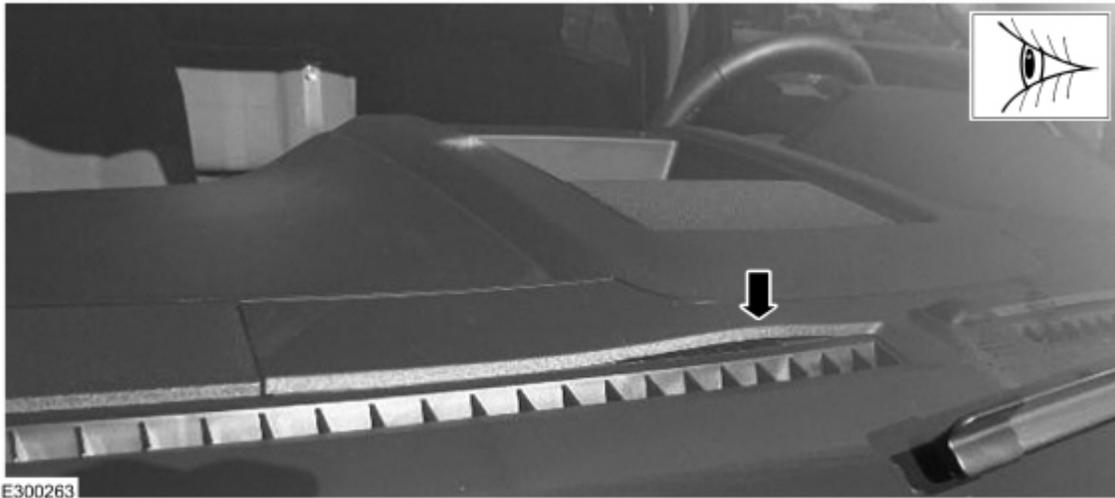
Figure 1

Issue: Some 2015-2019 F-150 XL/XLT vehicles may exhibit warping/separation of the instrument panel at the defrost vents. To resolve the condition, replace the instrument panel upper section.

1. Inspect the instrument panel. Does the instrument panel exhibit a warp/separation at the defrost vent as shown in Figures 1 and 2?

2. Replace the instrument panel upper section. Refer to WSM, Section 501-12.
