# Technical Service Bulletin

## 01 MIL on, DTC P243600 and/or P243700 stored in ECM

01 19 97 2049142/4 January 2, 2019. Supersedes Technical Service Bulletin Group 01 number 18-65 dated April 19, 2018 for reasons listed below.

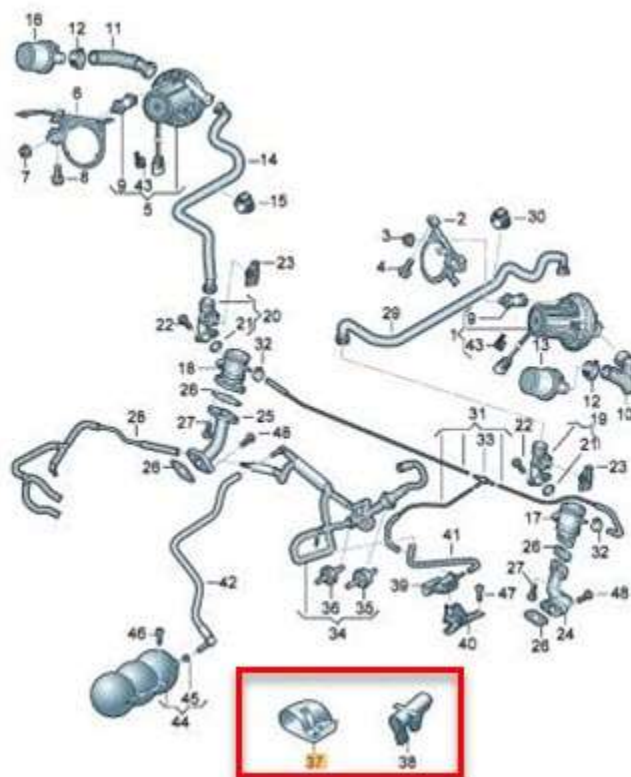
Figure 1. Replace the sender.

1. Replace the Differential pressure sensor Bank 2 (G610) according to the Repair Manual, *Engine >> 24 Multipoint fuel injection >> air filter housing, removing and installing >> 26 Exhaust System>Secondary Air System >> Combination valve, removing and installing >> Secondary air injection sensor G609/G610, removing and installing.*
2. Then add the insulation (Figure 1, number 37 and 38) on the pressure sensor Bank 2.  
At the end of the repair the pressure sensor and the combination valve should have the insulation on both banks (Figure 1, number 37 and 38). See Figure 2 for an example of installed insulation.
