Service Action

Code: 1906

Subject	Coolant Bottle
Release Date	February 27, 2019
Affected Vehicles	U.S.A. & CANADA: Certain 2018 MY Volkswagen Atlas <i>Check Campaigns/Actions screen in Elsa on the day of repair to verify that a VIN qualifies for repair under this action. Elsa is the <u>only</u> valid campaign inquiry & verification source.</i> <ul style="list-style-type: none">✓ Campaign status must show "open."✓ If Elsa shows other open action(s), inform your customer so that the work can also be completed at the same time the vehicle is in the workshop for this campaign.
Problem Description	The coolant level sensor may leak coolant through the electrical connector.
Corrective Action	Replace the coolant bottle and inspect coolant level sensor wiring connector.
Parts Information	Parts will be allocated prior to owner notification. If allocated parts have been used, please contact the Parts Specialists via phone (800-767-6552), email (VWoAPartsSpecialists@vw.com) or chat/text with the VIN to order.

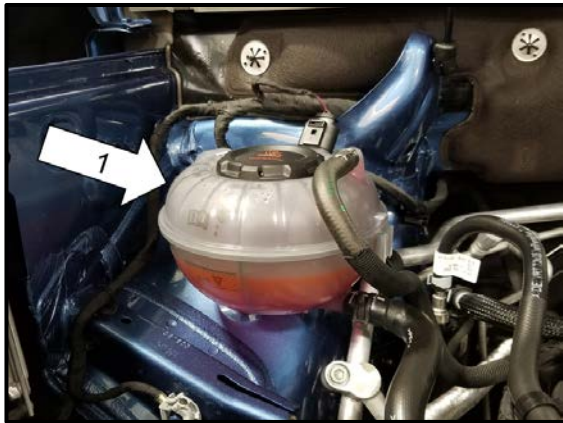
Repair Overview

- Replace coolant bottle <arrow 1>.
- Inspect coolant level sensor for coolant migration.

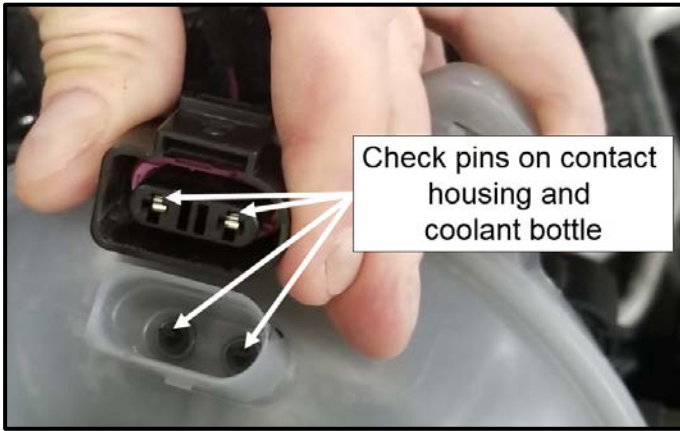
Inspect coolant level sensor wiring connector and coolant bottle connector housing:

- If coolant **IS** found at the coolant level sensor wiring connector and coolant bottle connector housing:
 - **Proceed to Section C** and inspect for coolant migration.
 - Coolant level sensor wiring connector will require repair.
- If coolant **IS NOT** found at the coolant level sensor wiring connector and coolant bottle connector housing:
 - Reconnect the coolant level sensor connector to the new coolant bottle.
 - **Proceed to Section E.**

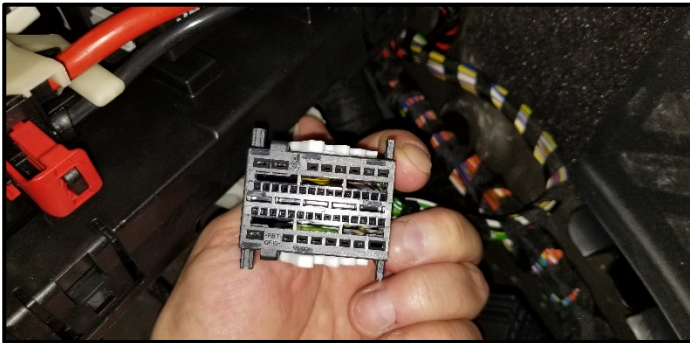
Inspecting -J519- Connector for Coolant Migration:

- Separate the individual terminal housings and inspect for coolant migration or corrosion.
 - See Appendix A for detailed disassembly instructions for separating the individual pin terminal housings from the -J519- connector housing.
- If coolant **IS NOT** found in the -J519- 46 pin connector:
 - **Proceed to Section D** and repair the coolant level sensor connector.
- If coolant **IS** found in the -J519- 46 pin connector:
 - Take clear photos of 46 pin connector showing coolant migration.
 - Proceed to the next step and generate a VTA WEB ticket.

- A VTA WEB ticket <arrow> must be created if coolant is found in the -J519- connector.
- Attach photos showing coolant migration, corrosion, or damage to the -J519- connector(s) to the VTA WEB ticket and await a response from Technical Assistance.

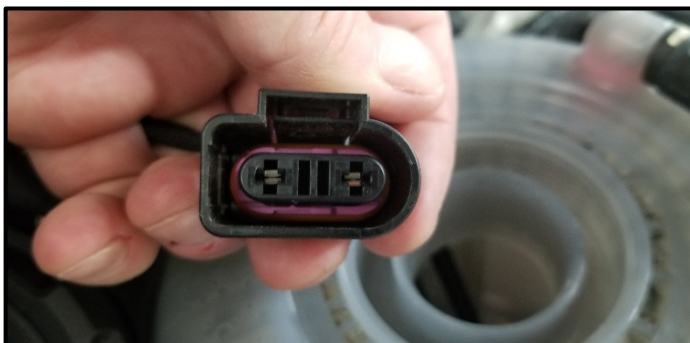
Repairing coolant level sensor connector (only if coolant was found in connector):

- If coolant migration or corrosion was discovered at the coolant level sensor connector, replace both wiring pins and seals.
