Technical Bulletin

Model(s)	Year	Eng. Code	Trans. Code	VIN Range From	VIN Range To
Passat	2012-2019	All	All	All	All

40 19 01 February 28, 2019 **2028353/11** Supersedes Technical Bulletin 40-14-06 (V401406) dated September 19, 2014 to include additional model year applicability.

Front Suspension Creaking Noise

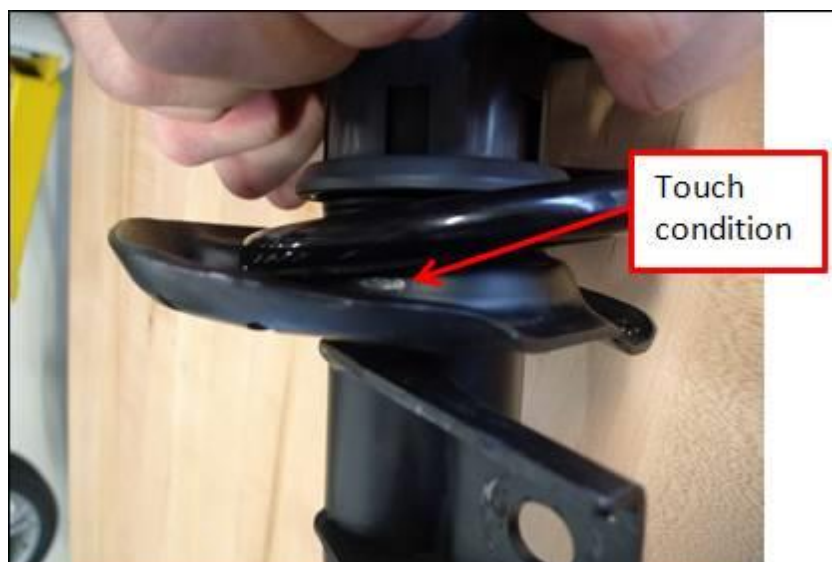
Figure 1

Coil Spring is not formed correctly and rubs against the perch of the strut.

A corresponding rub mark can be found on the coil spring using an inspection mirror.

- Verify if a car with the creaking noise has the contact mark (on one side or on both sides) as shown in figure 1.

- Remove affected suspension strut and disassemble, see Repair Group 40 in Elsa.
- Apply touch up paint to the contact area of the strut perch and allow required drying time.

- Install new spring on suspension strut (**per vehicle PR-codes**).
