Technical Bulletin

Model(s)	Year	Eng. Code	Trans. Code	VIN Range From	VIN Range To
Atlas	2018	All	All	CA_JC000001	CA_JC538732

66 19 01 February 11, 2019 **2050236** Supersedes Technical Bulletin 66-18-01 (V661801) dated March 20, 2018 to update exterior mirror labor operation number.

Exterior Side Mirror Wind Noise

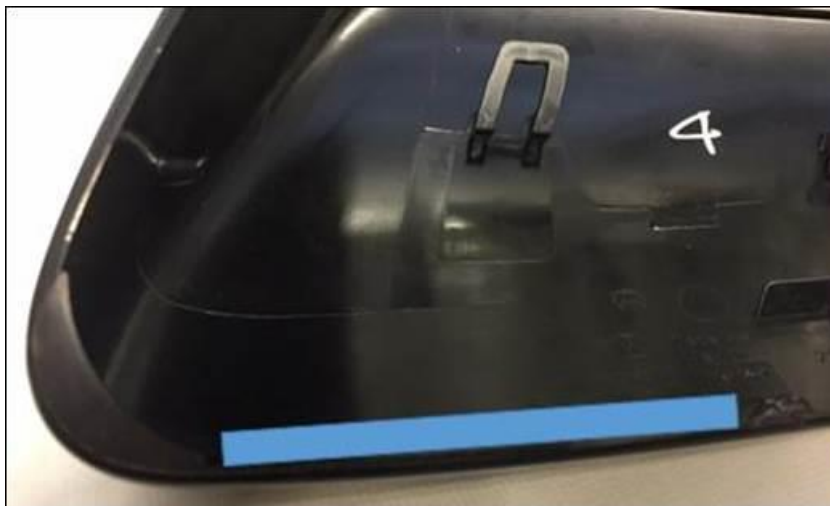
Figure 1

Wind noise inside cabin due to excessive gap between the mirror cap and metal bracket of the exterior mirror assembly.

- Remove the tape and affected mirror cover. See repair manual group 66 Exterior Equipment in Elsa.
- Thoroughly clean the inside area of the mirror cap with isopropyl alcohol and a microfiber cloth.
- Wait 5 minutes after cleaning the inside area of the mirror cap before proceeding to allow the alcohol to evaporate.
- Apply foam tape (part #1J0 971 798 and cut a strip 70 x 7mm) to the underside of the mirror cap as represented as the blue stripe in Figure 1.

- Apply foam tape to the underside of the mirror cap as represented as the blue stripe.
