Freightliner
Service Bulletin

ABS Light Illuminating in the ICU, ABS Solenoids Not Self Checking

54-302

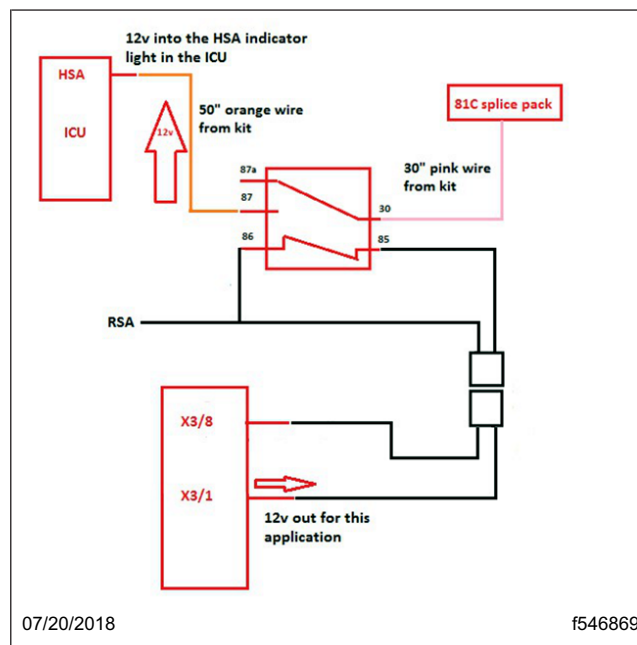
Fig. 1, Correct Wiring After the Procedure

The Hill Start Aid (HSA) telltale is driven by ABS ECU connector 3, pin 1, which is wired to a 120 ohm resistor, circuit 376N. This circuit seeks a grounding path through a splice to circuit 378RS-, which keeps the indicator from flickering during normal operation. Circuit 378RS- terminates at ABS ECU connector 3, pin 8. This input to ABS connector X3, pin 8 through the 120 ohm resistor causes the pin to degrade prematurely, causing the ABS light to self check when the key is turned to the ON position while the ABS solenoids do not self check.

See [Fig. 1](#) for a basic schematic of the retrofit with a relay.
