TECHNICAL SERVICE BULLETIN

Manual Liftgate Difficult To Close - Built On Or Before 1-Sep-2017

19-2057
28 February 2019

Ford 2017 Escape

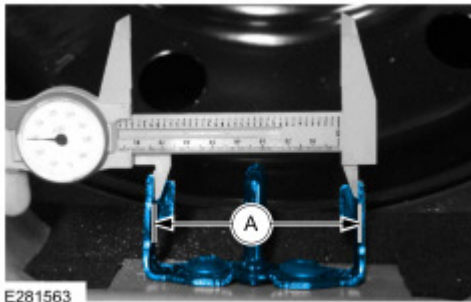
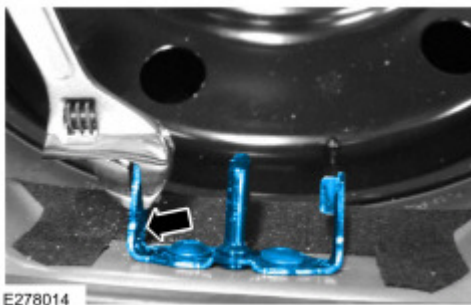
Issue: Some 2017 Escape vehicles built on or before 1-Sep-2017 may exhibit a manual liftgate that is difficult to close. This may be due to the striker wing position relative to striker. To correct the condition, adjust the striker wings to the specified specification.

7. Using an adjustable wrench, bend the striker wings outward equally on each side until 84.5-85.0 mm (3.327-3.346 inches) is attained. If bent too wide, gradually bend each side in equally to attain this distance. (Figures 7-8)
