# Technical Service Bulletin

## 01 MIL on, DTCs P20E900 or P20FE00 stored in ECM

01 19 12 2034359/8 March 15, 2019. Supersedes Technical Service Bulletin Group 01 number 19-05 dated February 13, 2019 for reasons listed below.

Model(s)	Year	VIN Range	Vehicle-Specific Equipment
Q7	2012 - 2015	All	TDI

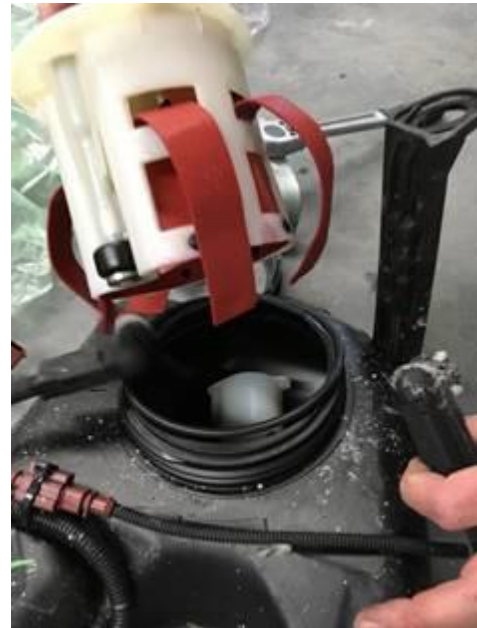
In vehicles produced during a certain period, the AdBlue filter seal within the level sensor module may have been damaged during the assembly process or the AdBlue filter housing may come loose over time. This can allow unfiltered AdBlue to be drawn into the delivery system, subsequently damaging the pressure sensor and reducing agent pump V437.

*Figure 1. Filter element housing is loose inside the tank.*

1. In cases with the above fault codes, remove the active tank according to instructions in the Elsa Repair Manual.
2. Remove the G684 Reducing Agent Tank level sensor.
3. Inspect the reducing agent filter housing which should be clipped to the G684 level sensor module. If the filter housing is loose (see Figure 1 and Figure 2), **then the G684 level sensor AND the V437 reducing agent pump must be replaced.**

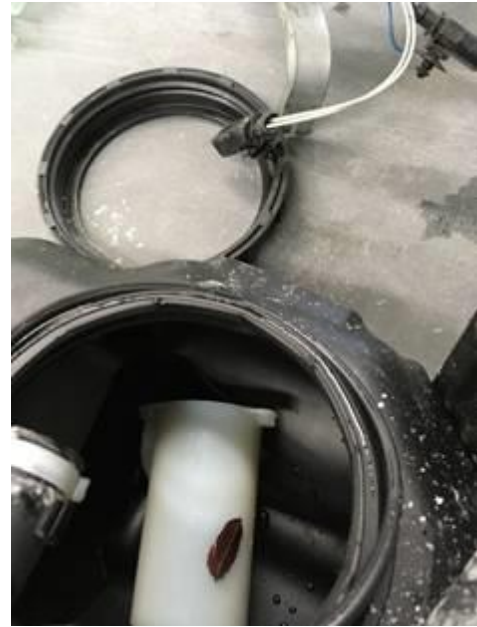
**Figure 2.** Filter element housing is loose inside the tank.
