# Technical Service Bulletin

## 37 Transmission malfunction, DTC P17F600, U008000, and/or U010100 stored in TCM or ECM

37 19 86 2053878/3 March 21, 2019. Supersedes Technical Service Bulletin Group 37 number 19-85 dated March 12, 2019 for reasons listed below.

Model(s)	Year	VIN Range	Vehicle-Specific Equipment
A6, A7	2019	000001 - 050600	3.0TFSI

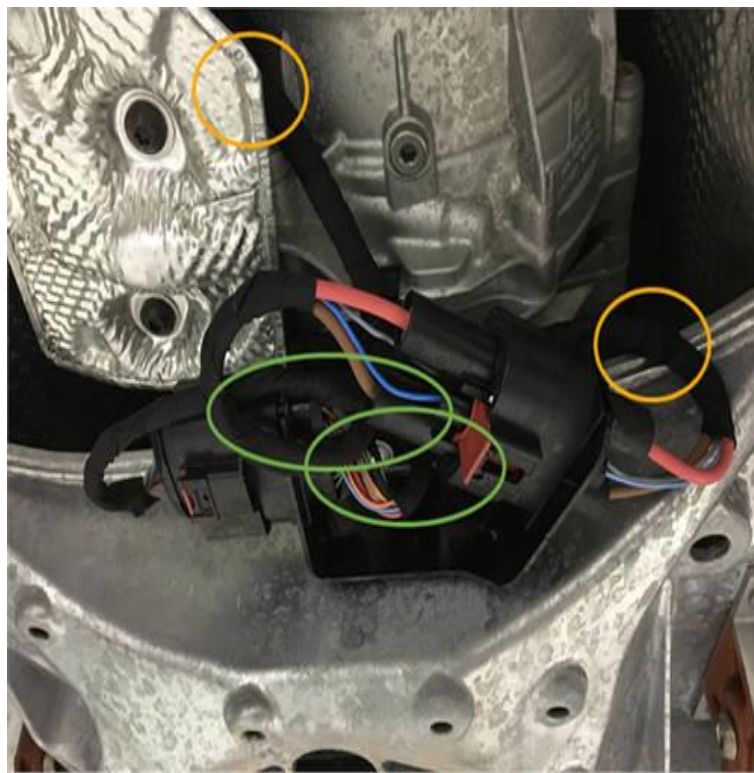
The transmission harness can come in contact with the crossmember and could be damaged.

**Figure 1.** Common areas for harness damage.

2. Replace the transmission harness with a new part and reroute the transmission harness. The transmission harness should not be repaired.

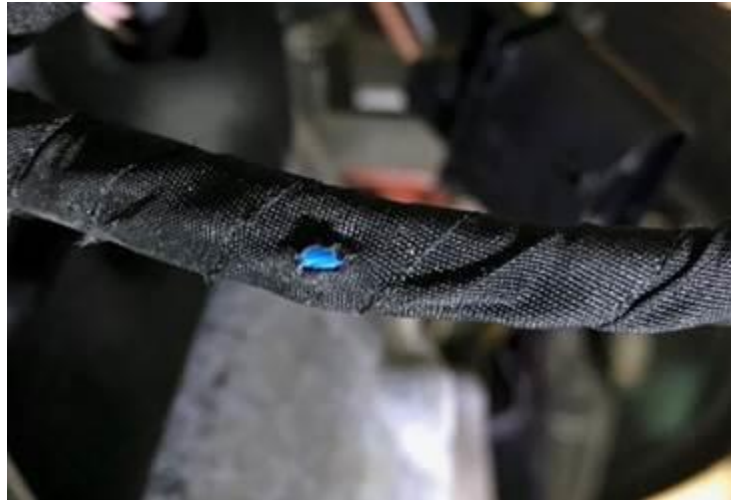
*Figure 2. Example of a small rip in the protective tape.*

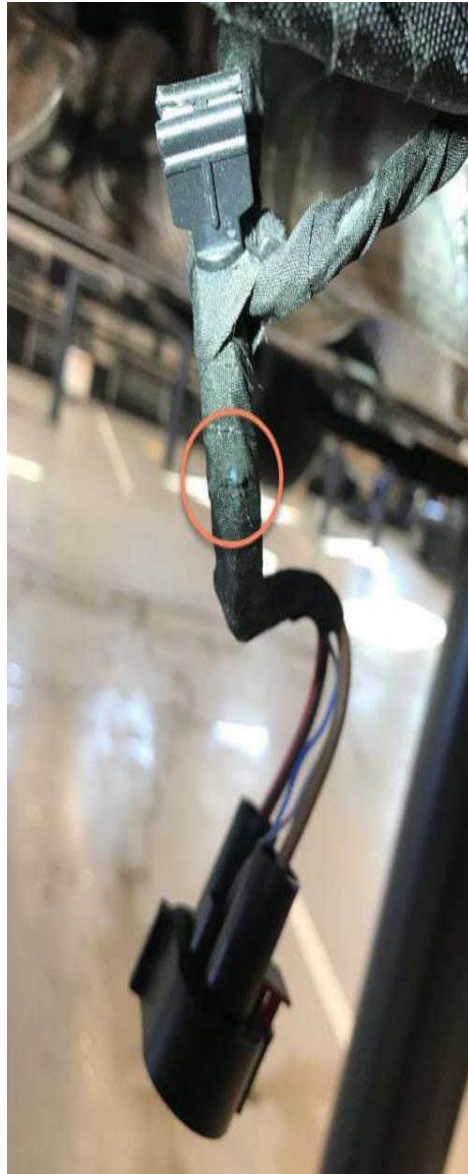
*Figure 3. The damage on the harness might be difficult to spot.*

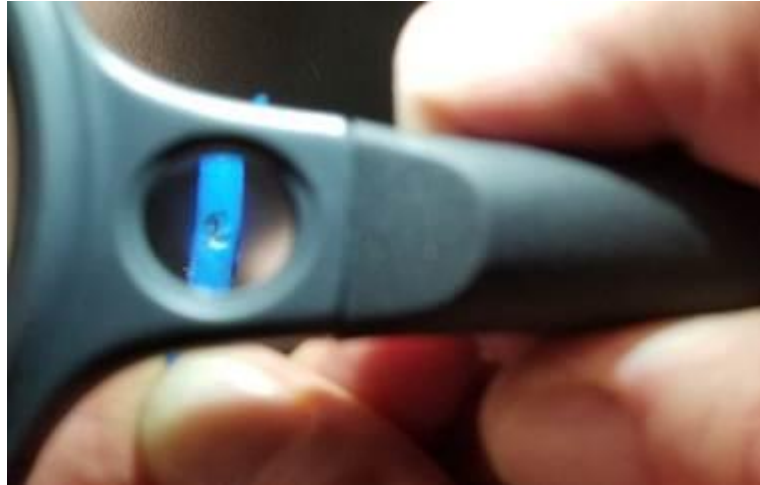
**Figure 4.** The cause of the DTC may be as small as a pinhole.
