Technical Service Bulletin

57 DTC B132E29 and B132F29 stored in the door control modules

57 19 55 2054419/1 March 26, 2019.

Model(s)	Year	VIN Range	Vehicle-Specific Equipment
A6, A7, A8, and Q8	2019	All	Not Applicable

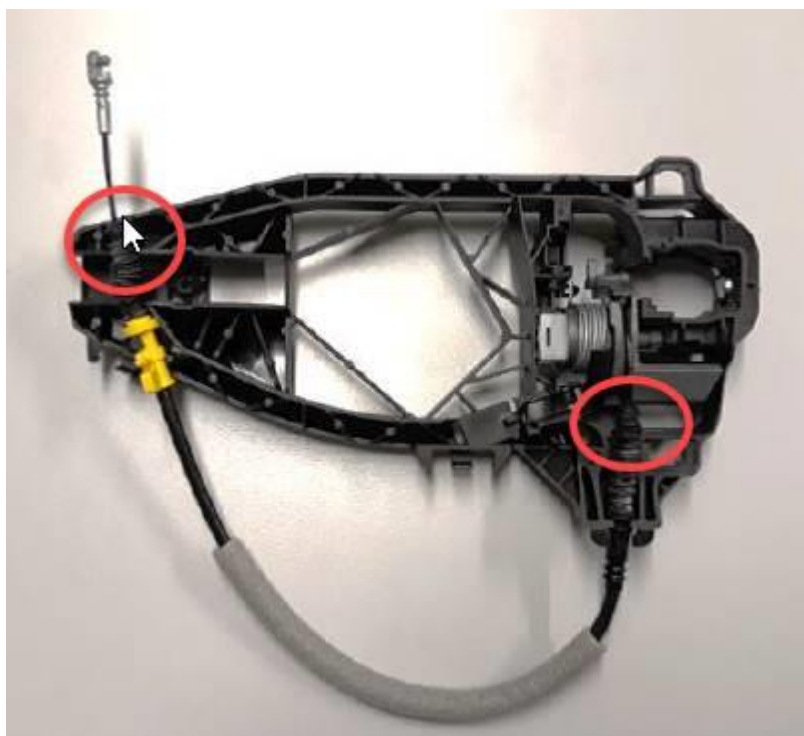
Figure 1. Remove Bowden cable.

1. Gain access to the Bowden cable for the affected door and remove it. It is possible to have water entry on both ends of the cable as shown in Figure 1.

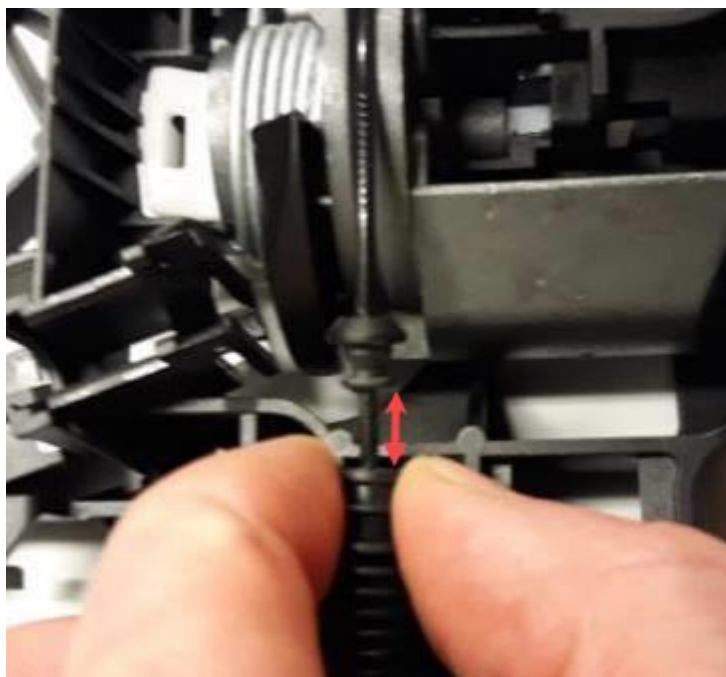
Figure 2. Separate the boot from the cable retainer.

2. With the cable removed, you will need to separate the boot from the cable retainer (Figure 2).

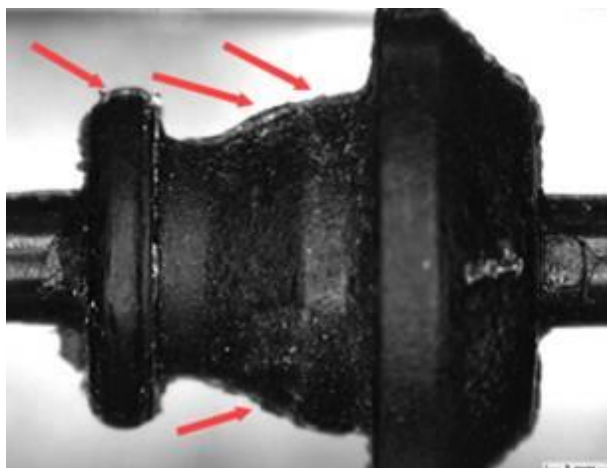
Due to some manufacturing residue left on the cable, water is allowed to enter the Bowden cable attached to the door lock, which can freeze and not allow the door to unlock. Once the vehicle is brought in the shop for a short period of time or left in overnight, you may not be able to reproduce this concern. It happens frequently when it is cold outside and the vehicle has been taken through a carwash. If the faults are stored, you can proceed with this bulletin without reproducing the concern.

Figure 3. Burrs that need to be removed.

3. In Figures 3 and 4, you can see the burrs that need to be removed from the retainer. They can be removed with a razor knife.

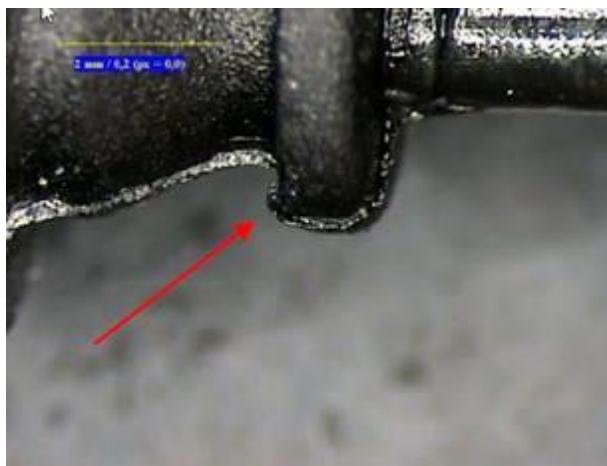
Figure 4. Burrs that need to be removed.

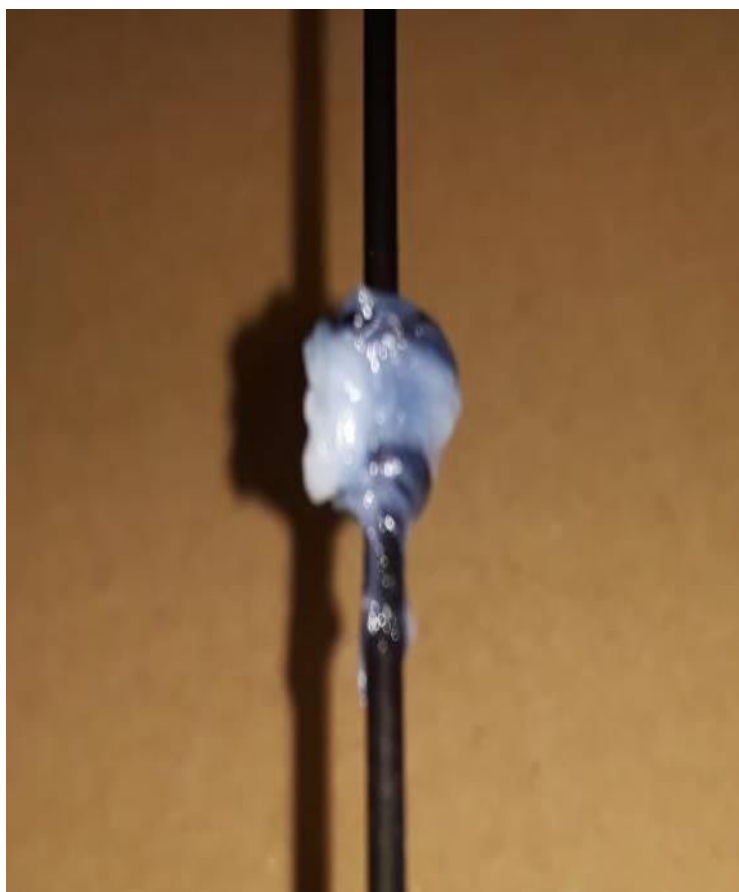
Figure 5. Apply the grease.

4. Apply the grease to both retainers on the cable. Only part number G 000 450 02 is to be used for this application (Figure 5).

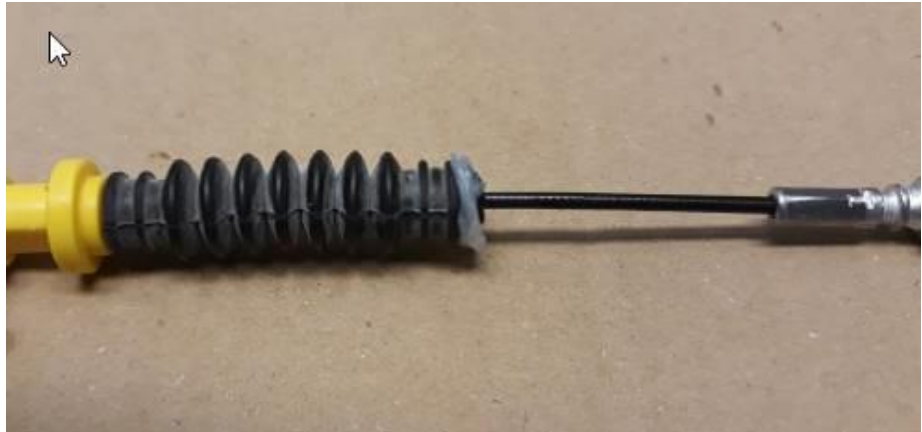
Figure 6. Grease should peek out of the grommet.

5. After applying the grease, the grommet can be pushed back onto the retainers. The grease should start to come out of the end of the grommet (Figure 6).
