Technical Service Bulletin

60 Rattle noise near central roof area

60 19 26 2054270/1 March 19, 2019.

Model(s)	Year	VIN Range	Vehicle-Specific Equipment
A6	2019	All	Not Applicable

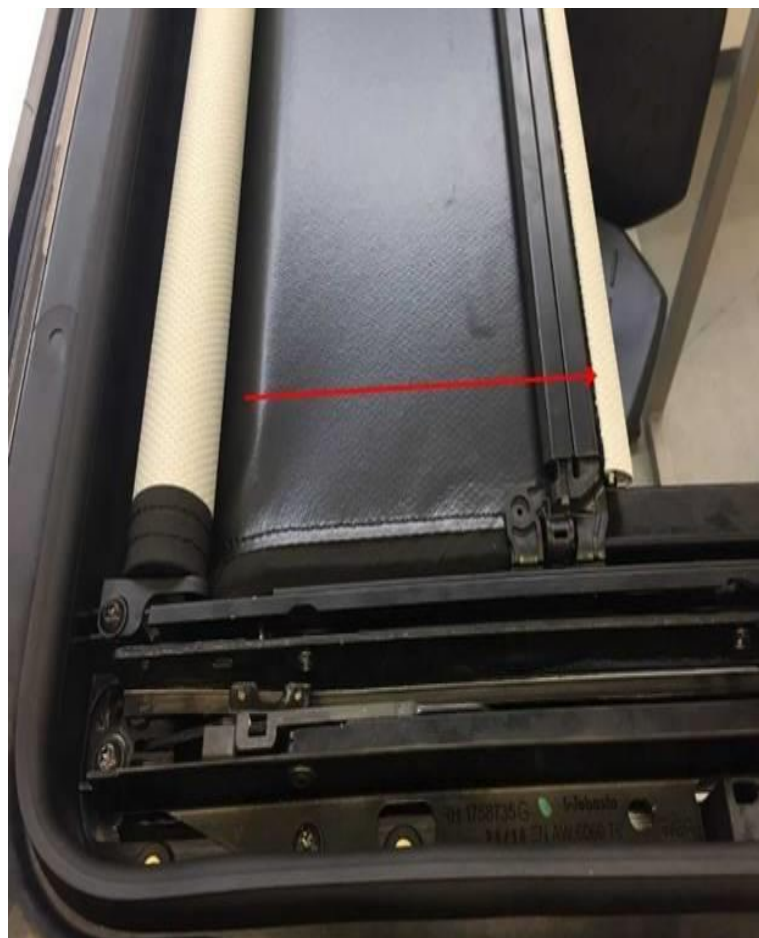
Figure 1. Closing the roller shade.

2. Close the roller shade by about 20cm (Figure 1).

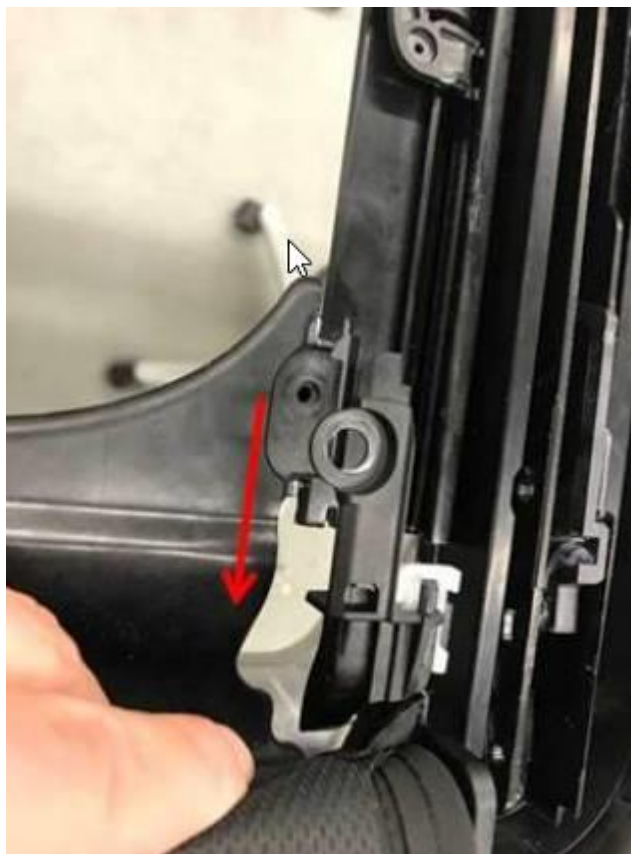
Figure 4. Slide roller shade backward.

4. Remove the roller shade by sliding it backward and clean the mounting points as shown in Figure 4 and 5. Use the cleaning solution D 009 404 04.

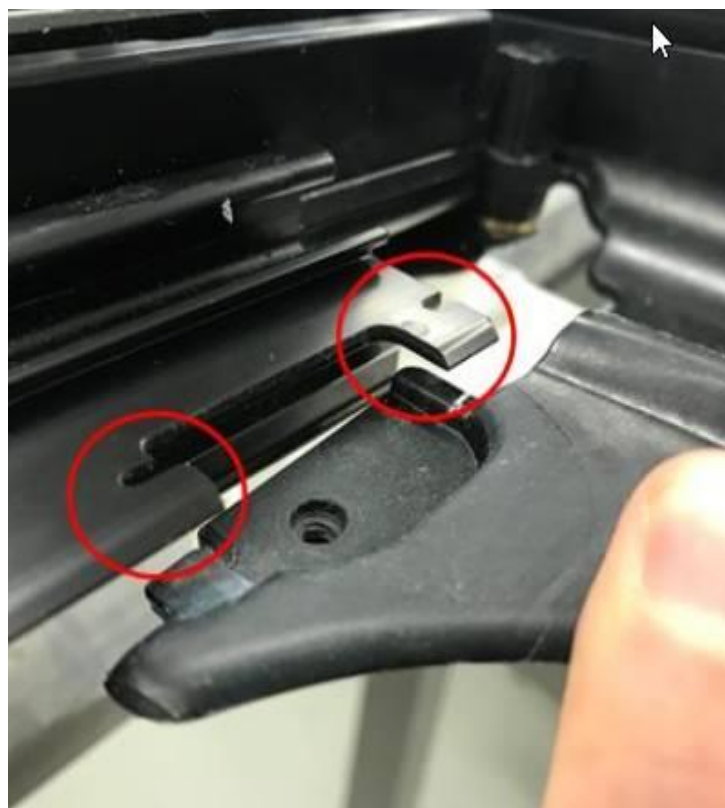
Figure 5. Removing the roller shade.

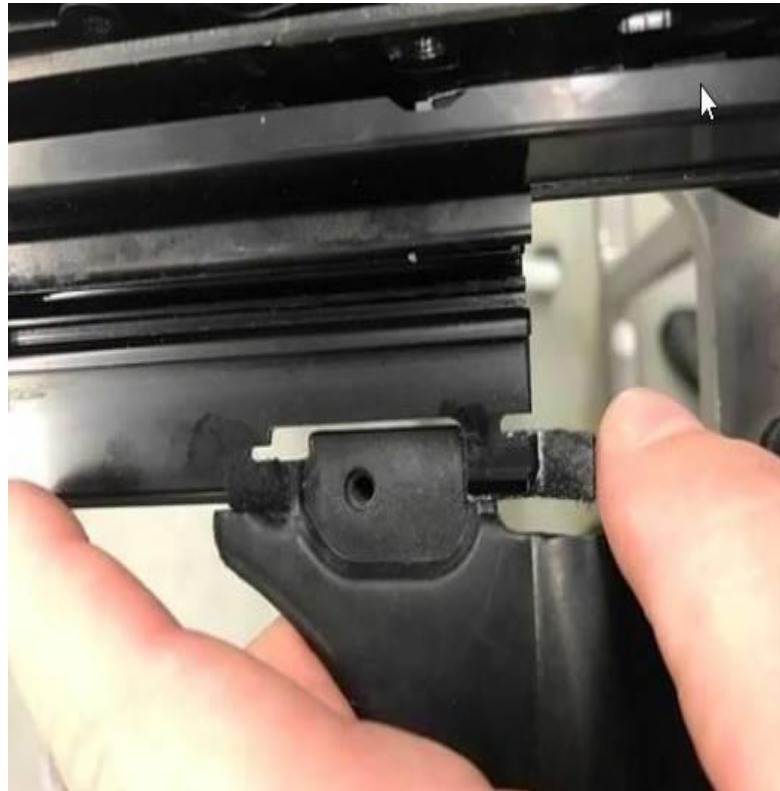
Figure 6. Applying felt tape.

5. Push down on the roller shade pan and starting from the bottom of the guide rail, apply the 1mm thick felt tape and fold them forward and over to the top of the guide rail (Figure 6 and 7).

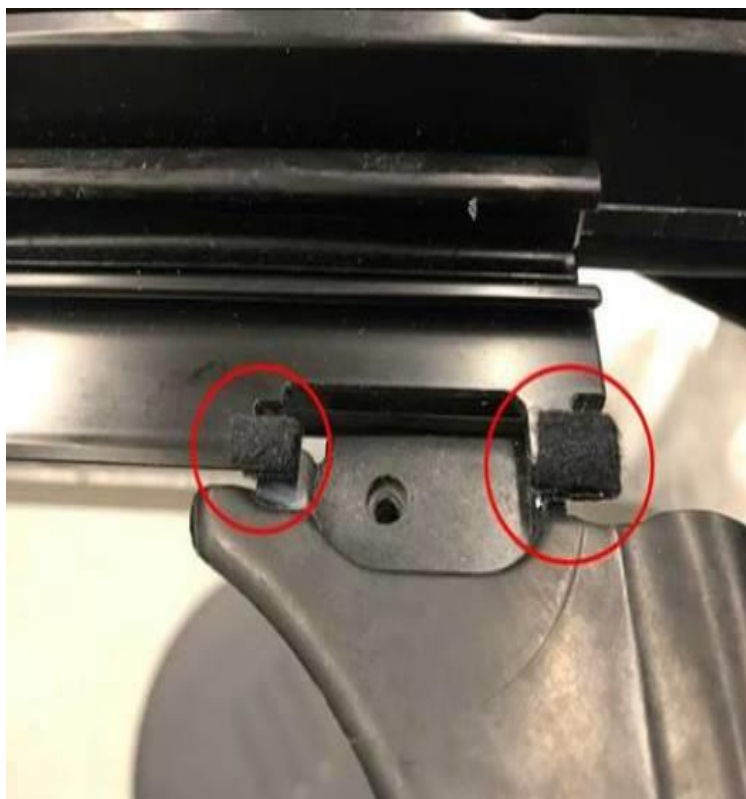
Figure 7. Apply felt tape on points shown.

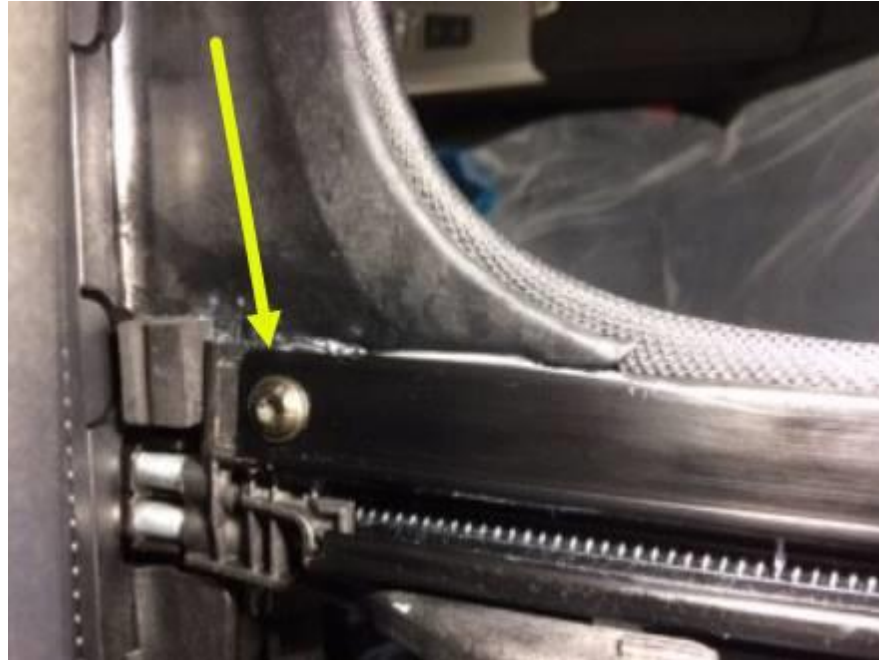
Figure 8. Loosen bolt and apply lube paste between these panels and under the bolt head. Reinstall bolt and torque to 5Nm.

7. On the front of the sunroof guide rail, loosen that bolt by 3mm. Lift the guide rail, closing the gap between the rail and the plastic head section. Apply lube paste G 060 576 7A2 between the two panels and also under the head of the bolt on the guide rail. Be careful to not get the lube paste on the threads of the bolt. Reinstall the bolt and tighten to 5Nm. (Figure 8).
