Technical Service Bulletin

PSS 90 Instrument cluster map is blank after start-up

90 19 11 2054351/1 March 26, 2019.

Model(s)	Year	VIN Range	Vehicle-Specific Equipment
A3	2018 - 2019	All	MIB2 High Navigation

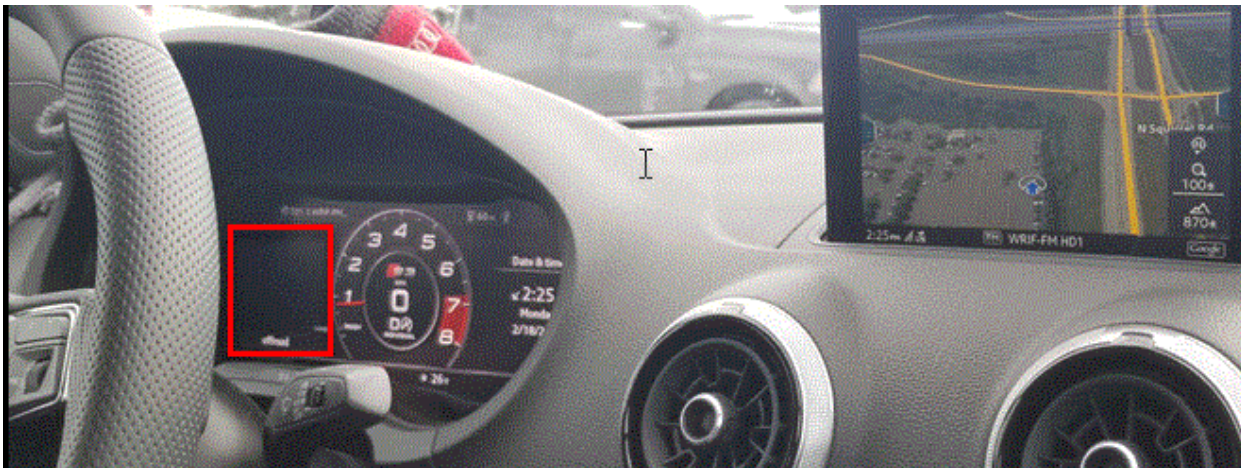
A software bug in the instrument cluster can cause the map not to display if the vehicle is placed in reverse after start-up, then put into park, and the driver's door is opened (Figure 1).

Figure 1. Map section is blank in the instrument cluster display.

1. Diagnose the vehicle according to the instructions listed below. If the customer's vehicle condition matches the condition listed in the *Technical Background* of this PSS TSB, explain to the customer that a solution is forthcoming and that no repairs are necessary at this point.
2. Do not replace any components for this condition since this will not resolve the customer's concern.
3. **Condition verification procedure:**
 - Check/Ask the customer if the map is/was visible in the middle of the speedometer when displayed with big tachometer/speedometer tubes.
 - If so, please follow TSB 2052820: *91 Audi virtual cockpit map section displayed inside the speedometer.*
4. Create a PSS record in the PSS application through the Pending Service Solutions (PSS) link in AccessAudi (under *Related Links >> Service*), or through the Technical Assistance Page in Elsa.
