Technical Service Bulletin

91 Droning noise from engine compartment from about 3500 rpm

91 19 50 2042374/2 March 26, 2019. Supersedes Technical Service Bulletin Group 91 number 15-23 dated November 6, 2015 for reasons listed below.

Model(s)	Year	VIN Range	Vehicle-Specific Equipment
S3, TTS	2015 - 2016	All	Not Applicable

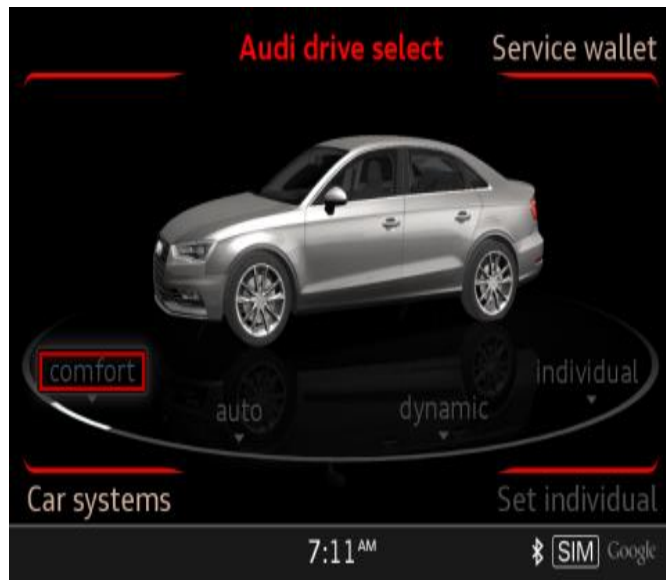
If the sound became more noticeable with Audi drive select in dynamic mode, then the source is the harness contacting the body structure. Proceed to the next step.

Figure 2. Audi drive select mode selection.

1. Verify the concern by checking for the sound with the engine speed between 3,500 and 4,000 rpm, only after the engine has reached operating temperature. This can be done while the vehicle is stationary.
 - First, check for the sound with Audi drive select in comfort mode (*MMI >> Menu >> Car >> Audi drive select >> comfort* or select using the dash panel button) (Figure 2).
 - Next, verify that the sound is more noticeable with Audi drive select in dynamic mode (*MMI >> Menu >> Car >> Audi drive select >> dynamic* or select using the dash panel button).

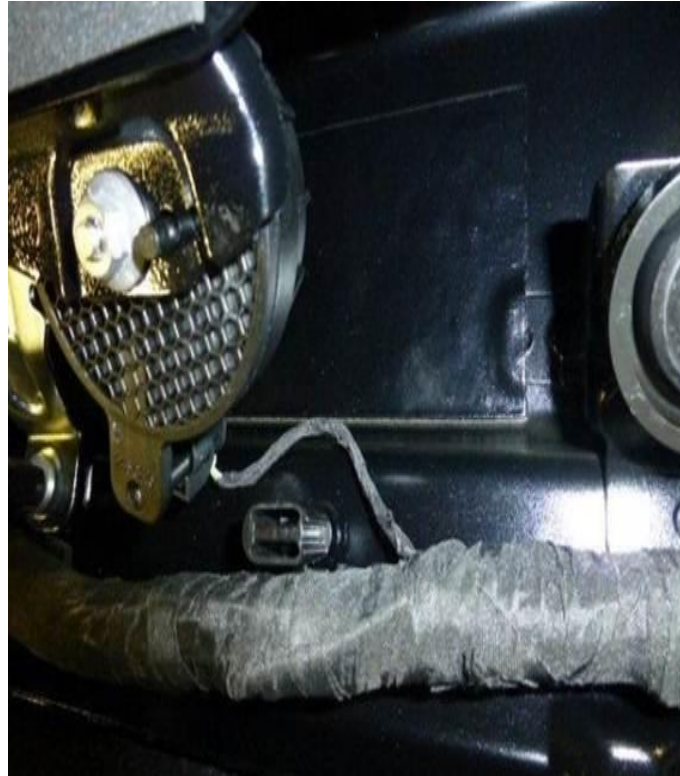
In S3 and TTS vehicles, there is an electronic sound amplification system (actuator for impact sound) that changes depending on the selected Audi drive select mode. The harness for the sound actuator can make contact with the vehicle body structure and the noise can be amplified by the sound actuator. This noise is only noticeable at higher speeds due to the calibration of the sound actuator system.

Figure 3. Sound actuator R214 in the plenum chamber.

2. Loosen the connector on sound actuator R214 (Figure 3) according to the Elsa Repair Manual.

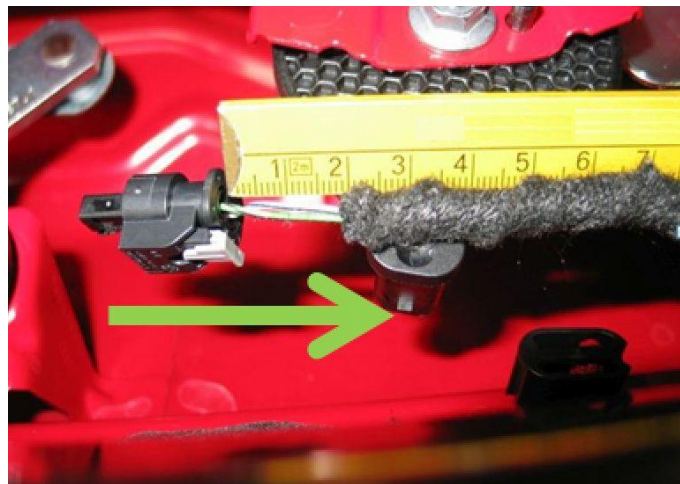
Figure 4. The direction in which to start wrapping the tape (arrow).

3. Wrap fleece tape (part number D 373125A2) from approximately 2 cm away from the connector housing to the exit of the main wiring harness (Figure 4).

The new tape can be placed over the existing insulation. The added bulk will dampen vibrations.
