## TECHNICAL SERVICE BULLETIN

**19-2072**

**Intermittent Power Mirror And/Or Power Window Operation From Master Switch - Built On 23-Jul-2018 And Through 07-Nov-2018**

Lincoln 2019 MKC
---------------------

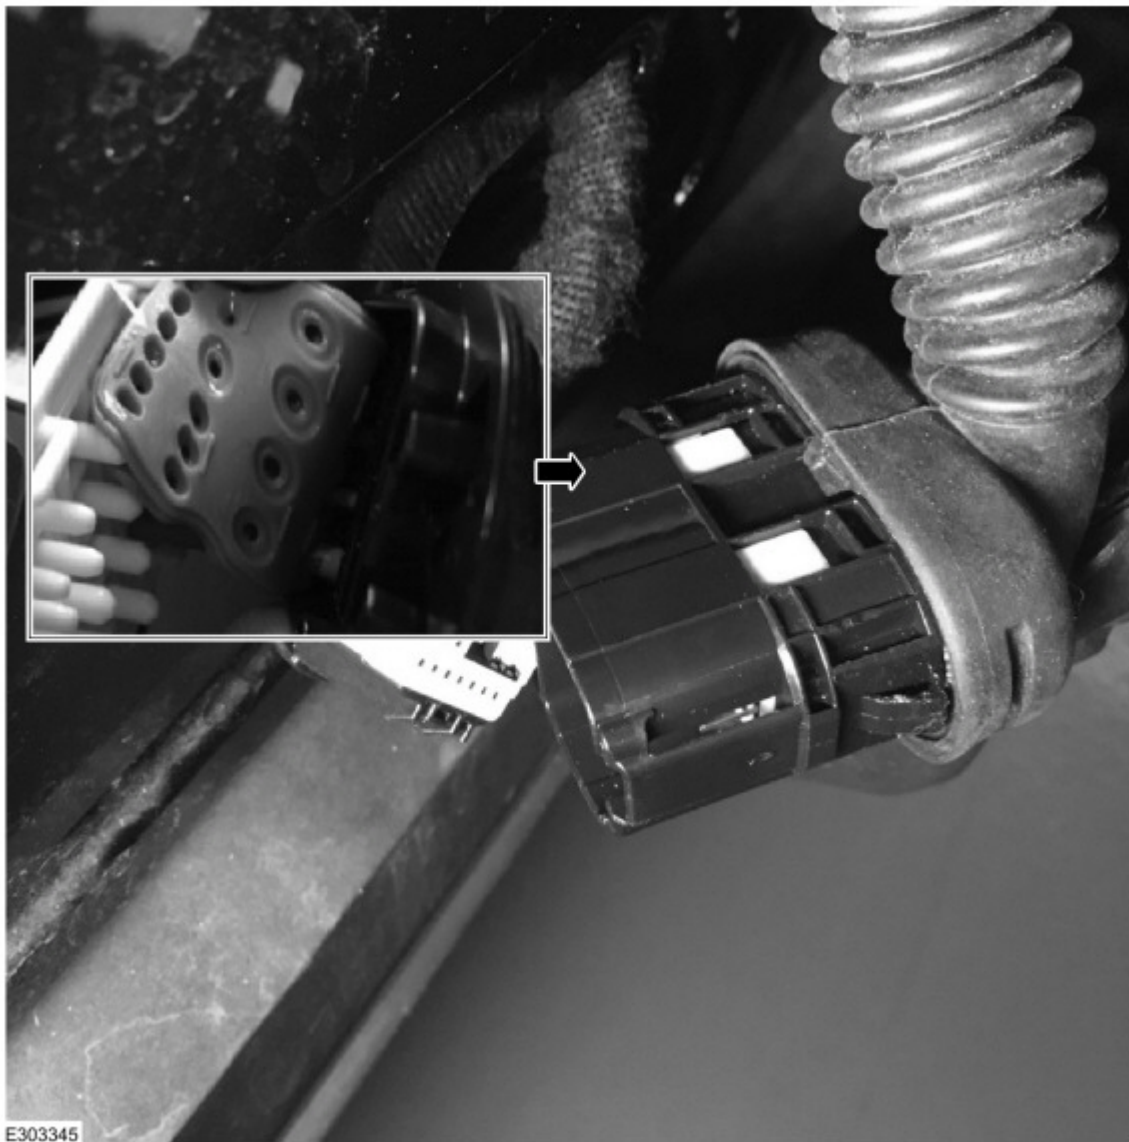
Figure 6

6. Disassemble the hard shell connector attached to the grommet and inspect for water intrusion. (Figure 6)
