TECHNICAL SERVICE BULLETIN

Water Entering Right Front Footwell Through HVAC Fresh Air Inlet

19-2084
19 March 2019

Lincoln 2017-2019 Continental

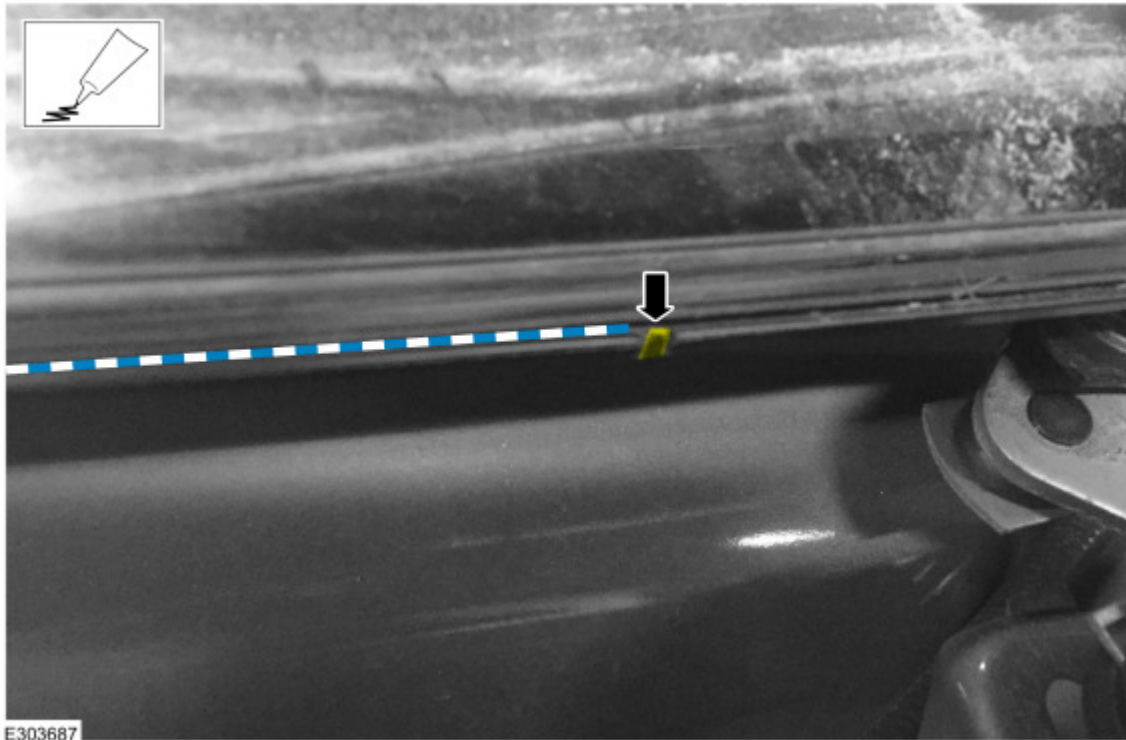
Figure 1

Issue: Some 2017-2019 Continental vehicles may exhibit water entering the right front footwell through the heating, ventilation and air conditioning (HVAC) fresh air inlet. This may be due to water leaking through the seam between the windshield and the cowl panel grille. To correct the condition, add sealant to this seam.

1. Remove the cowl panel grille. Refer to Workshop Manual (WSM), Section 501-02.
2. Apply a bead of Motorcraft® Seam Sealer or equivalent, approximately 1.5 mm (0.059 in) wide, to the lip at the base of the windshield where the rear edge of the cowl panel grille seats. This bead should run from the locating notch at the center of the windshield along the right half of the windshield, continuing through to the end of where the windshield and the cowl panel grille meet. (Figures 1-2)
