March 14, 2019

SUBJECT: **Customer Satisfaction Program 19N02**
Certain 2015-2018 Model Year F-150 and 2017-2018 Model Year F-250-F550
Vehicles - Post-18N03 Repair Enhancements

REF : **Customer Satisfaction Program 18N03 - Supplement #4**
Certain 2015-2018 Model Year F-150 and 2017-2018 Model Year F-250-F-550
Vehicles - Door Latch Freezing Concerns

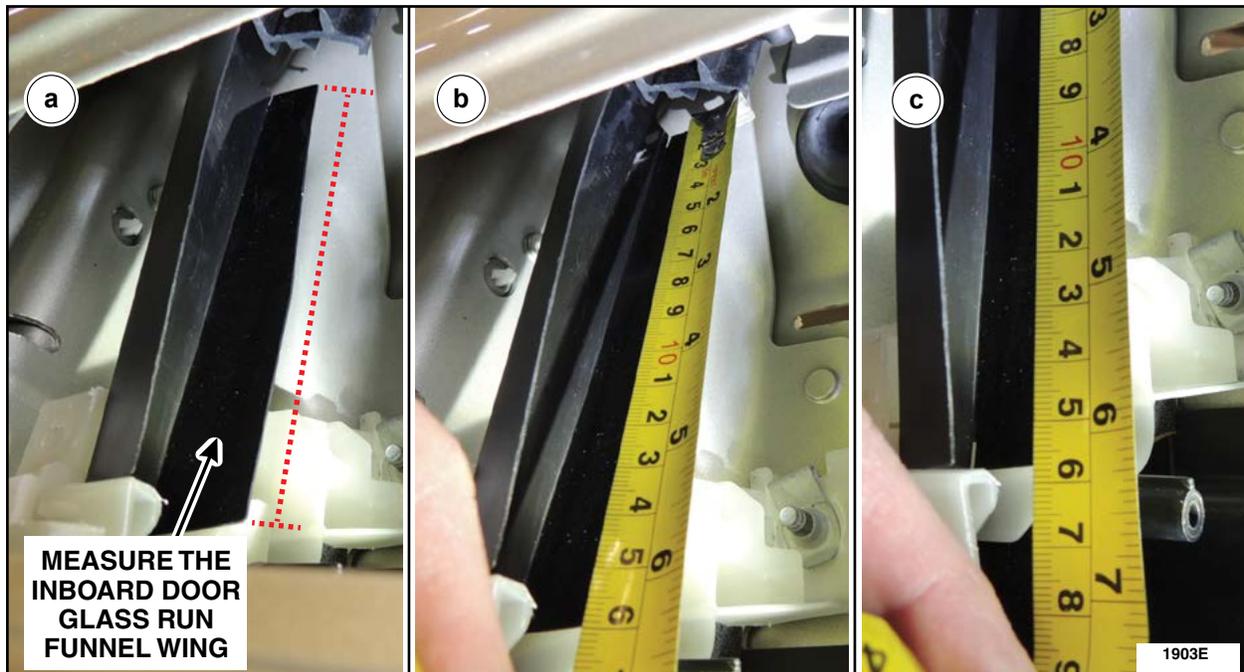
FIGURE 3

5. Are the door glass run funnels the correct length (157mm)?

4. Measure the door glass run funnel inboard wing for proper length (157mm). See Figure 3.
Refer to ATTACHMENT V - Door Glass Run Funnel Measurement Guide for additional information.

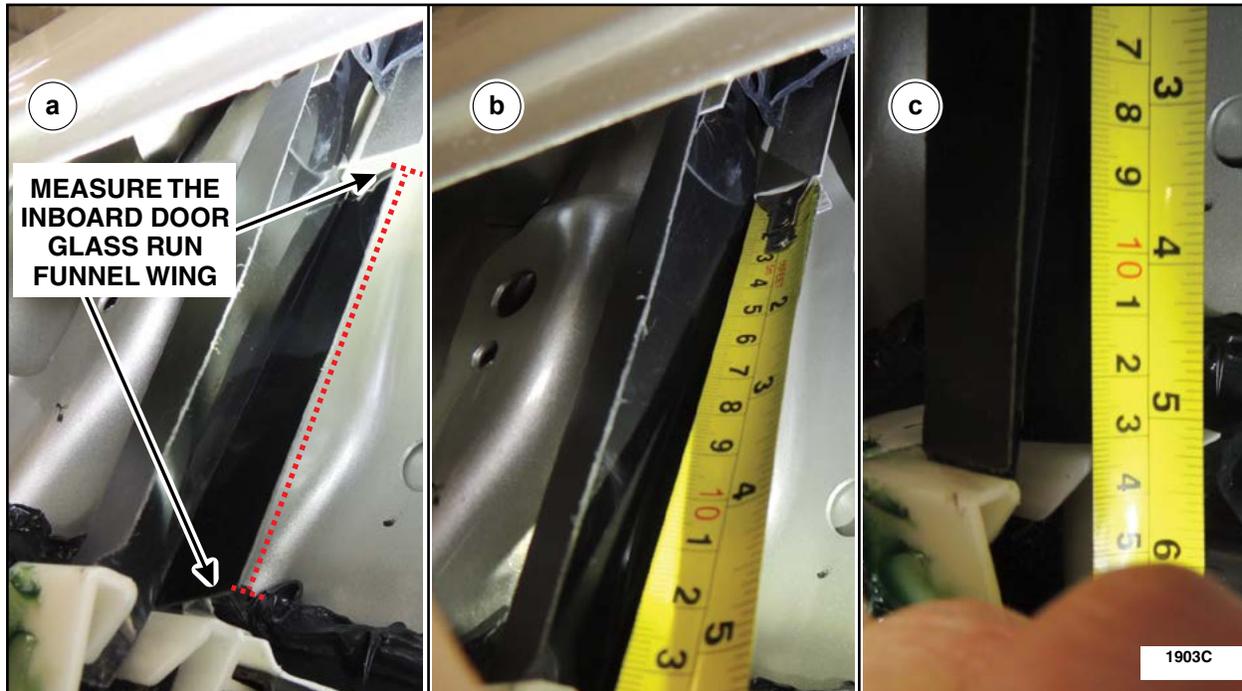
FIGURE 24

4. Are the door glass run funnels the correct length (132mm)?
 - Yes - Door glass run funnel inspection complete. Proceed to Step 12.
 - No - Install a *new* door glass run funnel. Proceed to Step 5.
5. Position the window to the open (down) position.

3. Measure the door glass run funnel wing for proper length (132mm). See Figure 24.
Refer to ATTACHMENT V - Door Glass Run Funnel Measurement Guide for additional information.
 - a. From the exterior door handle opening locate the door glass run funnel.
 - b. Extend the tape measure up and hook the top of the inboard wing of the door glass run funnel.
 - c. Measure to the bottom of the inboard wing of the door glass run funnel. See Figure 24.
Proceed to Step 4.

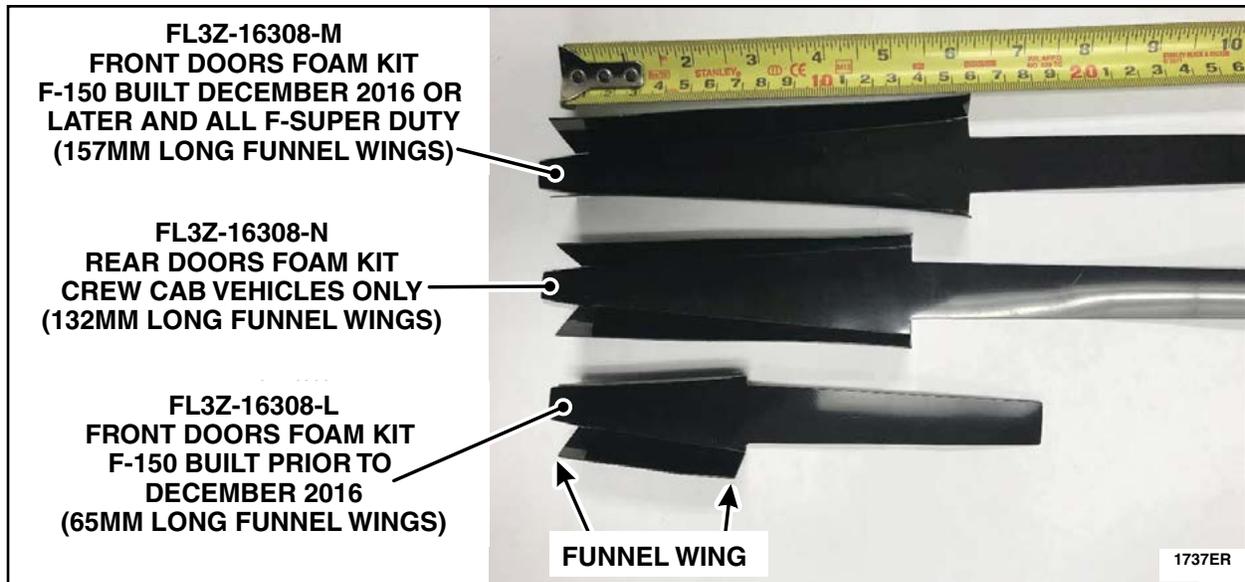
FIGURE 1

Some of the door foam kits were packaged with incorrect size door glass run funnels. Dealers are to measure the door glass run funnel wings using the measurement guide below. If a door foam kit is found to have incorrect size door glass run funnels the correct size door glass run funnels can be removed from another kit, and that additional kit the door glass run funnels were removed from can also be claimed with this repair. All unused parts from the additional kit can be scrapped.

NOTE: This packaging error caused rear doors foam kit FL3Z-16308-N to be incorrectly packaged with door glass run funnels from front doors foam kits FL3Z-16308-M. Conversely, the front doors foam kits FL3Z-16308-M were also incorrectly packaged with door glass run funnels from rear doors foam kit FL3Z-16308-N. If foam kits FL3Z-16308-M or FL3Z-16308-N are found to have incorrect funnels the correct funnels can likely be found in the other kit.

1. Verify the correct door glass funnels are being installed by measuring the funnel wings as shown in Figure 1.
