Technical Bulletin

Model(s)	Year	Eng. Code	Trans. Code	VIN Range From	VIN Range To
Tiguan LWB	2018-2019	All	All	AX_JM000001	AX_KM088514

60 19 02 March 27, 2019 2054353

Sunroof Water Leak, Reduced Adhesion Causing Loose Seal

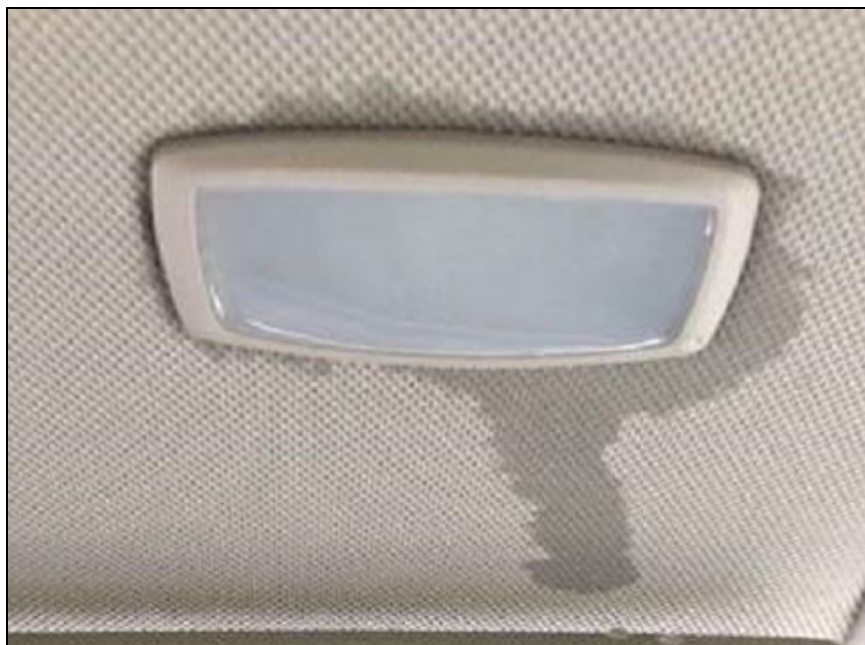
Front headliner area is wet around the vanity light(s), sunroof, and overhead console area due to water entering via the sunroof.

Water leak is due to poor adhesion of the sunroof body side seal to the body.

Figure 1: Example of water leak coming from the front vanity light.

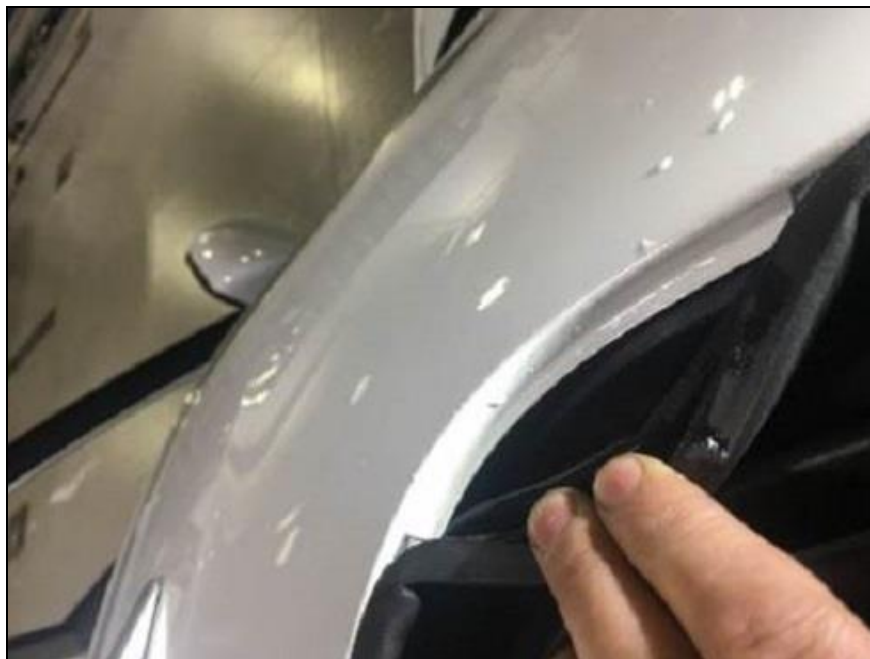
Figure 2: Example of the sunroof body side seal not having proper adhesion to the body.

- Remove the sunroof frame per ELSA repair instructions, “Body -> Body Exterior -> 60 Sunroof -> Sliding Sunroof -> Sunroof Frame, Removing and Installing” in Elsa.
- Remove the sunroof body side seal per ELSA repair instructions, “Body -> Body Exterior -> 60 Sunroof -> Sliding Sunroof -> Sunroof Seals, Removing and Installing -> Outer seal, Removing and Installing” in Elsa.

Start by pulling slightly on the body side seal and moving along the seal to confirm proper adhesion of the seal to the body until the seal is completely off. Once the seal has been removed, inspect it for non-adhered sections.

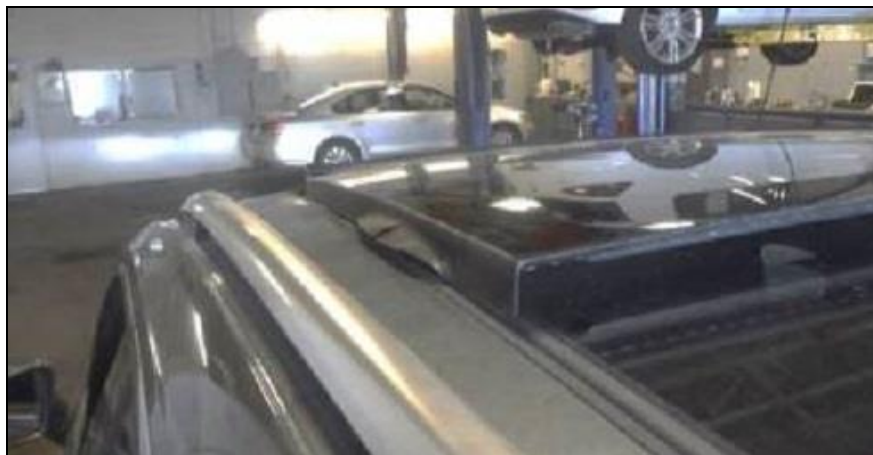
Figure 3: Example of the sunroof panel molded seal warped/deformation.

- Visually ensure sunroof panel molded seal and body side seal have no deformation.

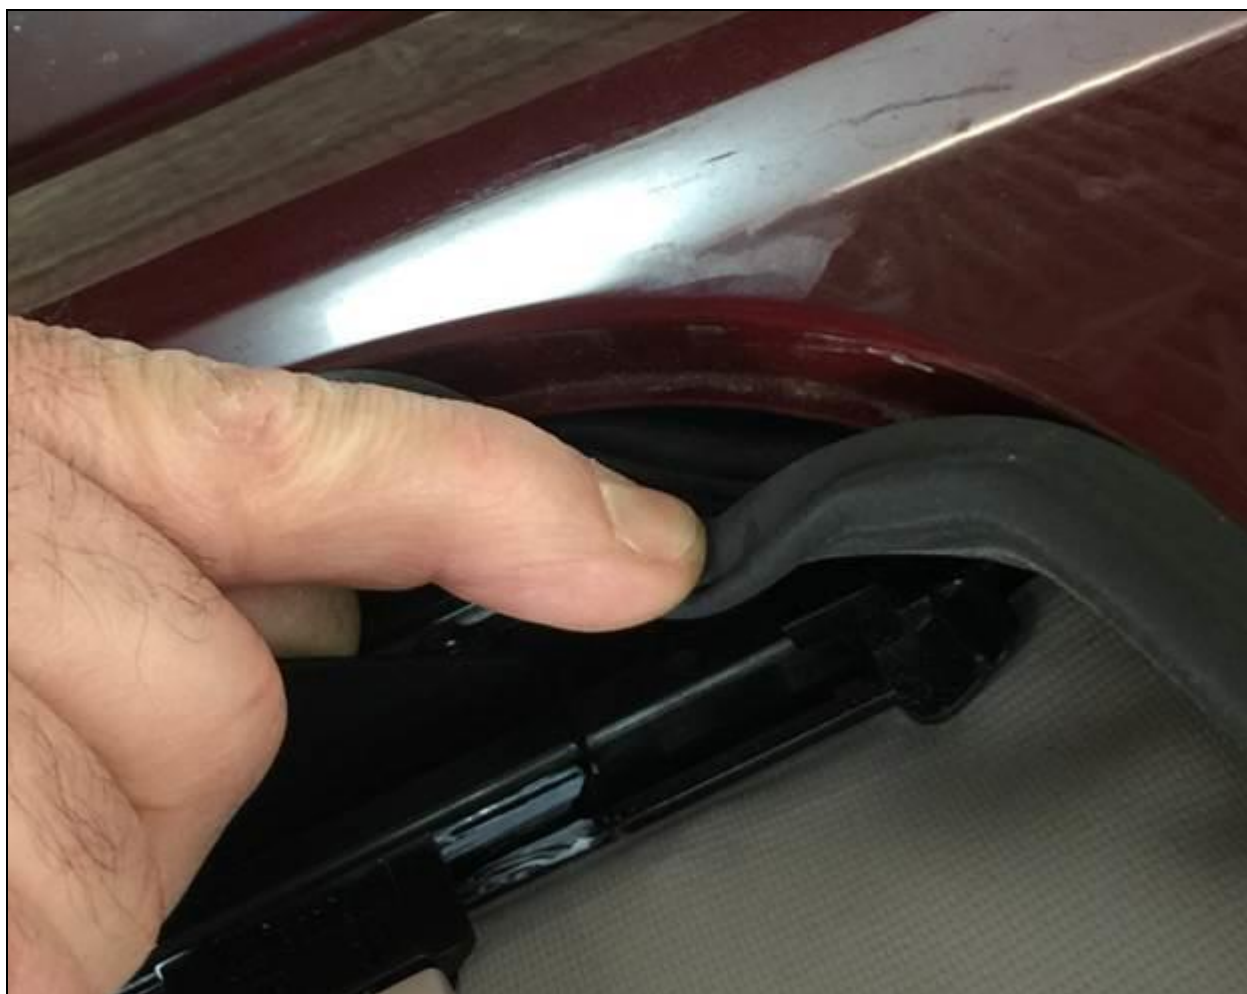
Figure 4: Example of a adhesion issue photo for uploading into WISE.

Take photos of the seal and body sections that were not adhered to the body and upload to WISE for a valid warranty claim.

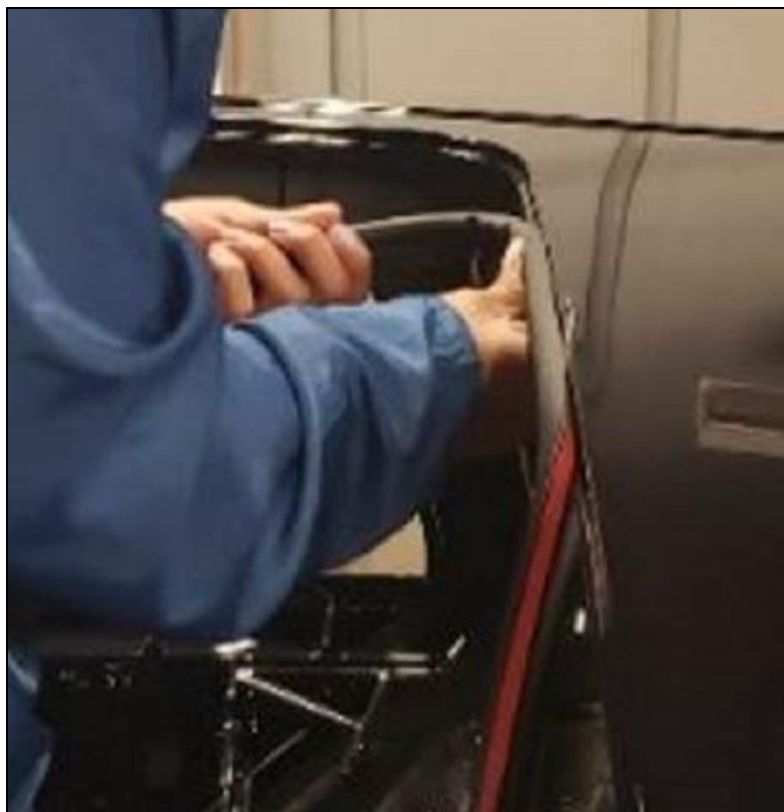
Figure 5: Example of installing the body side seal WITHOUT removing the “red” protective tape.

During the initial installation process DO NOT remove the “red” protective tape on the seal. Remove the “red” protective tape ONLY after the seal has been properly seated (Figure 5).

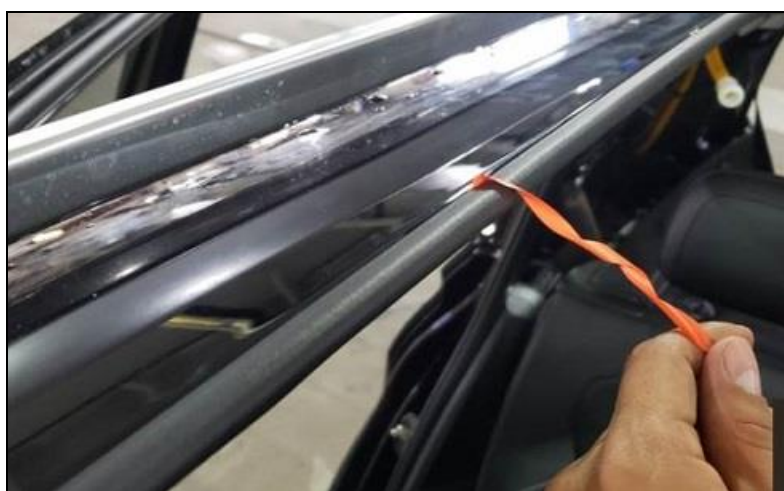
Figure 6: Example of removing the “red” protective tape after seal has been properly seated.
