Service Action Code: 60D8

Subject	In-Line Fuses for Sunroof LED Modules		
Release Date	March 20, 2019		
Affected Vehicles	U.S.A. & CANADA: Certain 2018 MY Volkswagen Tiguan		
	Check Campaigns/Actions screen in Elsa on the day of repair to verify that a VIN qualifies for repair under this action. Elsa is the <u>only</u> valid campaign inquiry & verification source.		
	 ✓ Campaign status must show "open." ✓ If Elsa shows other open action(s), inform your customer so that the work can also be completed at the same time the vehicle is in the workshop for this campaign. 		
Problem Description	The power supply to the sunroof LED module was disabled under Safety Recall 60D1.		
Corrective Action	IMPORTANT: Vehicles without an-service date at the time Safety Recall 60D1 was performed are <u>NOT</u> eligible for this service action.		
	Install in-line fuses for the left and right sunroof LED modules.		
Parts Information	If your dealership is at the weekly Upper Order Limit, please submit the backordered sales document number to <u>upperorderlimits@vw.com</u> to have additional parts released.

Subject: Service Action 60D8 - In-Line Fuses for Sunroof LED Modules Certain 2018 Model Year Volks

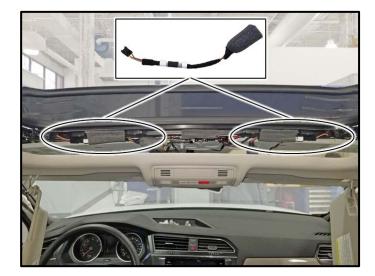
Inspect for previous installation of in-line fuses:

- If the fuses are found to be already installed • <circles>, and the panoramic roof ambient light LED's are functioning properly:
 - Reinstall the headliner in reverse 0 order of inspection. All work is complete.
 - Proceed to Section E. 0
- If the fuses are NOT installed:
 - Proceed to Section C and install the 0 in-line fuses.
