Document ID: IK1600207

Title: Wind noise at upper side of cab door

Applies To: All steel NGV cabs: ProStar, Pre-2018 LoneStar, TranStar, WorkStar, DuraStar, TerraStar. (Does not apply to CV, MV, HV, RH, LT, 2018 LoneStar, PayStar, HX)

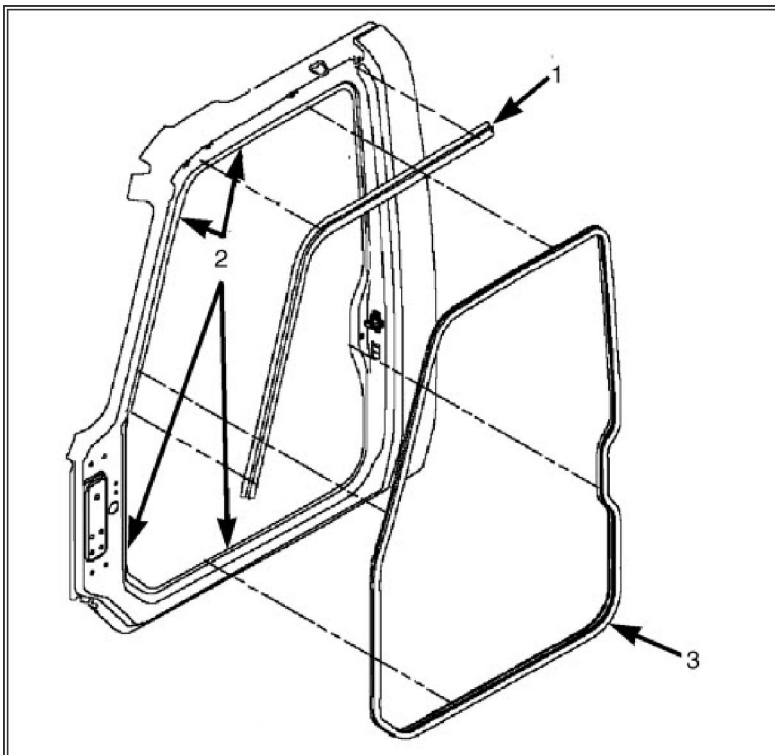
Figure 1: Door Seals

There are instances when the cab side entry door does not have proper contact with the door seals along the top of the door causing wind noise and/or flutter sounds. In extreme cases and in inclement weather, there could be water intrusion as well. Many design improvements were made between 2004 and 2009 that drastically improved quality in this area, however there are still isolated occurrences when this issue still persists in an older cab.

1. Inspect the primary (Figure 1, Item 3) and secondary (Figure 1, Item 1) door seals. Ensure they are seated down completely. If there is any visible damage or waves, adjust or replace as necessary.

3. After replacing or adjusting any of the parts in steps 1 or 2, remove the primary door seal (Figure 1, Item 3).
4. While closing the door, place a dollar bill or similar size/shape piece of paper between the secondary door seal (Figure 1, Item 1) and the door (Not Shown) at the base of the A-pillar where the secondary door seal starts/terminates just above the upper door hinge (Figure 2, Item 1).

5. Slide the dollar bill up and along the door all the way back to the upper rear corner of the door.
6. If the dollar bill does not slide freely, there is proper contact between the door and seal and no shimming is required. Reinstall the primary door seal (Figure 1, Item 3), ensuring that it is completely seated all the way around the door perimeter. The job is complete.
