Service Bulletin

Bulletin No.: 18-NA-270

Subject: Multiple Electrical Concerns, Intermittent Multiple Instrument Panel Cluster (IPC) Warning Lamps Illuminated, Intermittent Multiple Message on Drivers Information Center (DIC), Malfunction Indicator Lamp (MIL) Illuminated - Multiple Codes Set

Brand:	Model:	Model Year:		VIN:		Engine:	Transmission:
		from	to	from	to		
Chevrolet	Camaro	2016	2019			6.2L (RPO LT1)

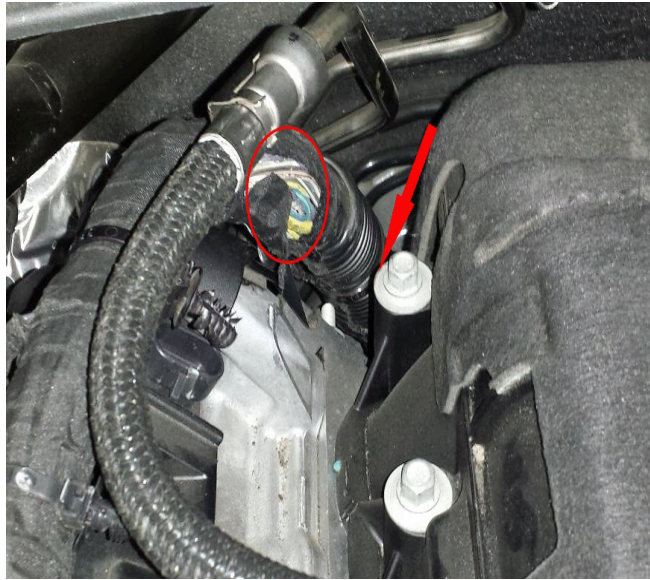
5138718

- The engine wiring harness chaffing on the right rear intake manifold bolt/washer, causing the circuit to short to ground.

Correction	<p>Note: Possible multiple effects or driver notifications may be experienced by one of the wires in the engine harness being chafed or cut in different circuits. Due to the cause of the condition, and the positions of the wires in the engine harness, it is unlikely that more than one circuit and/or fuse will be affected by the condition.</p> <ol style="list-style-type: none"> 1. Inspect the engine wiring harness conduit and wires for chaffing. 2. Repair the wires per the <i>Wiring Repairs</i> procedure in SI. 3. Using Woven Polyester Electrical Tape (PET), tape all the contact points of the engine harness ensuring that the tape is applied in a double layer extending along the engine harness. 4. Utilizing tie straps, position the engine wiring harness away from the edge of the intake manifold bolt.
-------------------	--

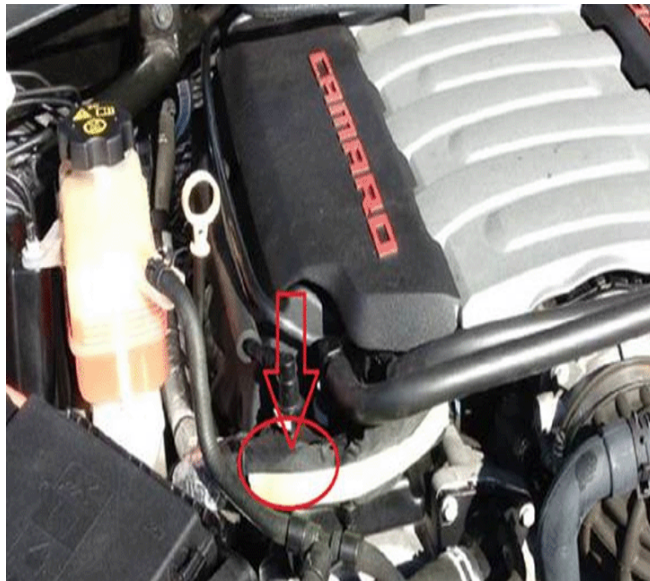
5227385

- The engine wiring harness chaffing on the positive crankcase ventilation hose/pipe/ tube, causing the circuits to short out.
