Service Bulletin

Bulletin No.: 18-NA-322

Subject: Drone Type Noise Heard While Air Conditioning (A/C) is On

Brand:	Model:	Model Year:		VIN:		Engine:	Transmission:
		from	to	from	to		
Chevrolet	Trax	2018	2019			1.4L (RPO LUV)

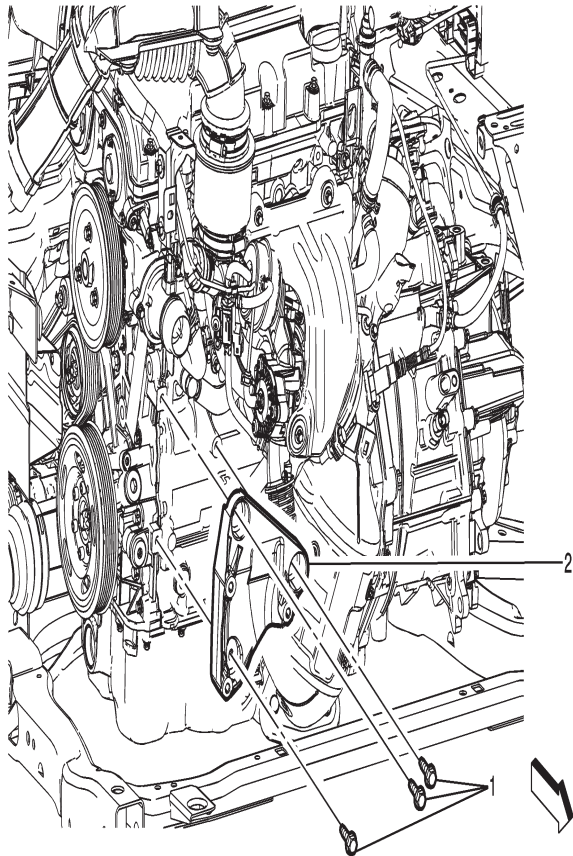
Involved Region or Country	North America, South America
Condition	Some customers may comment that a drone type noise can be heard when the A/C is on.
Cause	This condition may be caused by the A/C compressor mounting bracket bolts bottoming out in the engine block.
Correction

<p style="text-align: right;">2790949</p> <p>If the droning noise has been validated to be caused during A/C compressor operation, replace the bracket bolts (1).</p>

Refer to *Air Conditioning Compressor Bracket Replacement* in SI.

Causal Part	Description	Part Number	Qty
N/A	BOLT, HFH, M8X1.25X30.7, 26 THD, 18 OD, 8.8, GMW3359, M-PT	11588724	3
