Service Bulletin

Bulletin No.: 18-NA-365

Subject: Stalling, Lack of Engine Performance, Fuel Range Displays Low Mileage When Fuel Gauge Displays Adequate Fuel, Malfunction Indicator Light (MIL) Illuminated - DTC P018B, P0461, P0462, P0463, P0464, P2066, P2067, P2068, P2635 Set

Brand:	Model:	Model Year:		VIN:		Engine:	Transmission:
		from	to	from	to		
Buick	Enclave	2017	2018			LFY, LGX	
Cadillac	XT5						
Chevrolet	Traverse						
GMC	Acadia

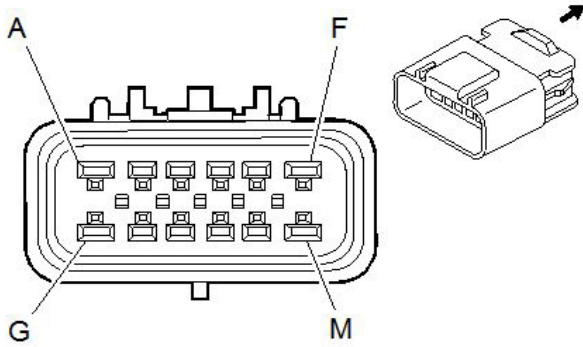
5182955

1. Check fuel level sensor resistance for both fuel level sensors at the x350 connector (Chassis Harness to Fuel Tank Harness). Refer to Document ID: 4733540 in SI.
 - If primary and secondary sensors are both at 250 ohms (Indicates that entire tank is empty and transfer of fuel is occurring), refer to Fuel Gauge Malfunction in SI (AWD).
 - If primary is at 250 ohms, and secondary is less than 250 ohms (indicates primary side empty, secondary side has fuel), proceed with procedure.
