Preliminary Information

PIT5499A ABS or ESC MIL on Service Trailer Brake Message or Low Brake Fluid Warning

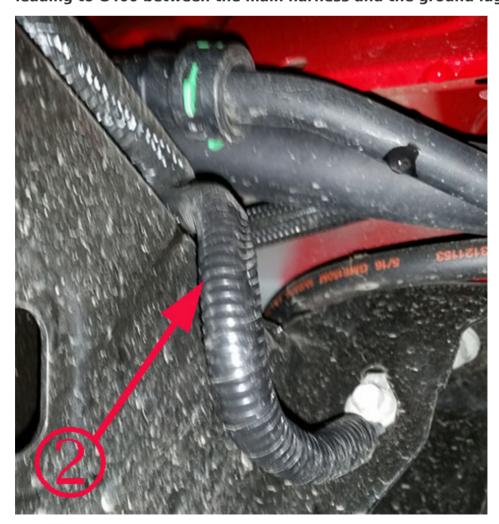
The customer may state the ABS / ESC MIL is on , the Low Brake Fluid lamp on (master cylinder fluid level is full) or a Service Trailer Brake message. The technician may find codes C0035, C0040, C0045,C0050, C0055, C0267, U0121, U0415 or U0420.

Inspect the EBCM connector for water intrusion or terminal corrosion. If either is found, replace the EBCM and replace the effected terminals. Remove the tape from the conduit leading to G400 between the main harness and the ground lug.

If no water intrusion or corrosion is found in the connector, remove the tape from the G400 conduit and continue with published diagnostics. Please note in the repair information if there

was water in the conduit.
