Preliminary Information

PIT5426B Second Row Seat Belt Wet And/Or Carpet Wet from the C-Pillar Area Rearward

Models

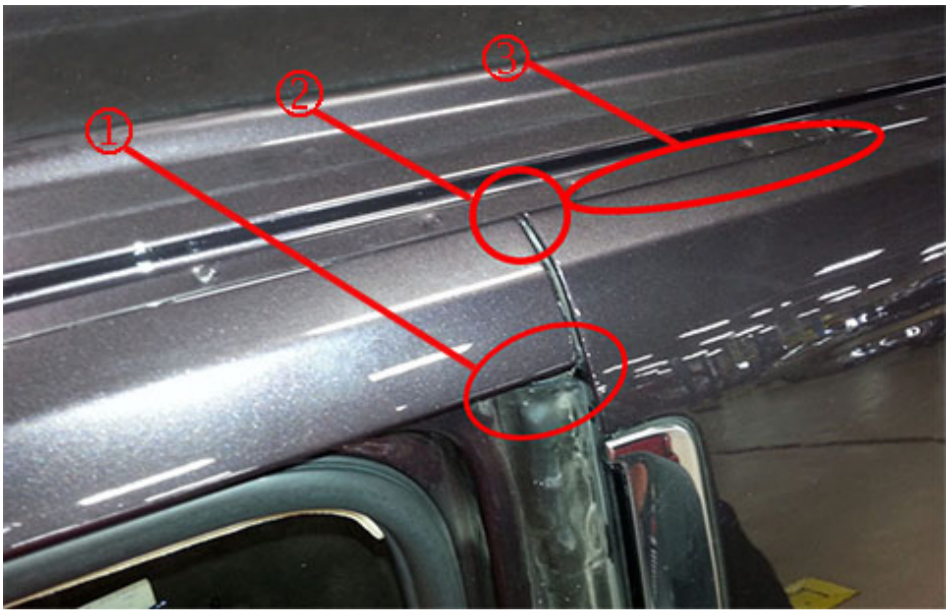
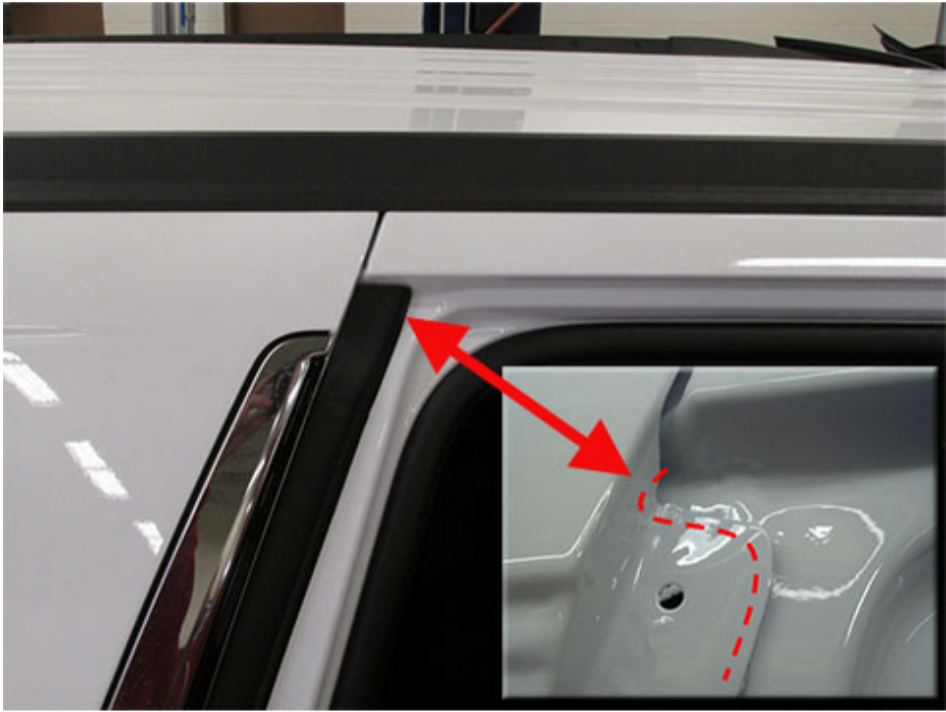
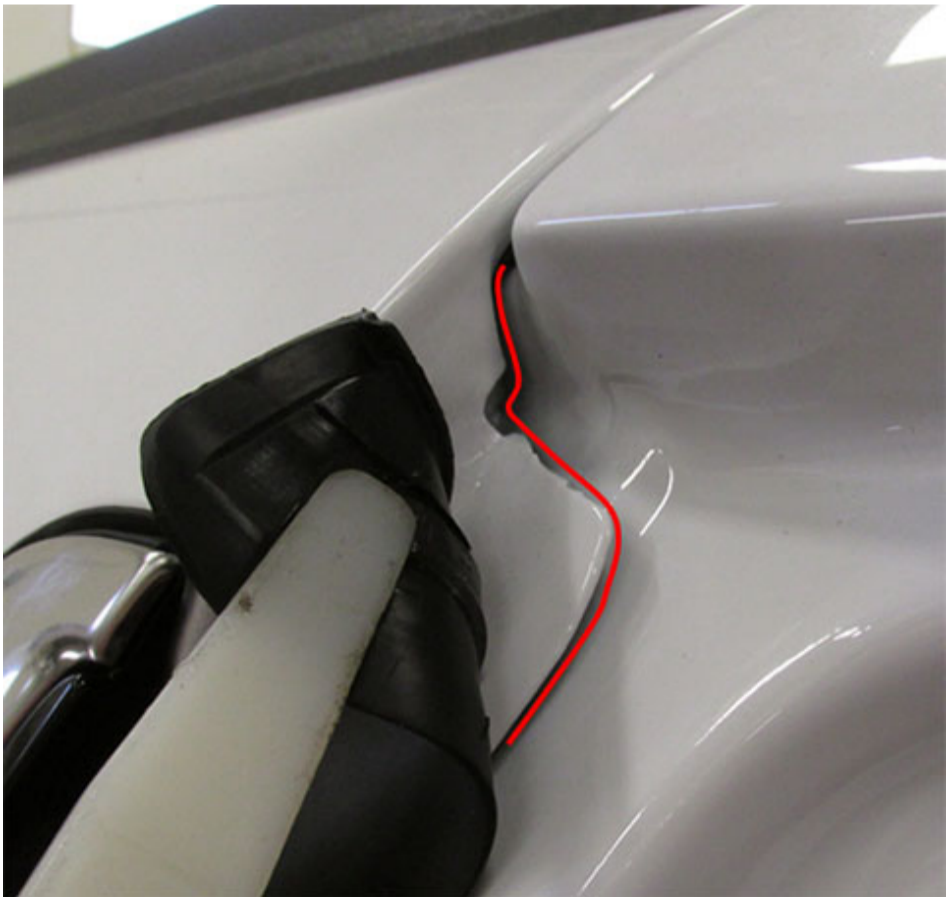
4 - With the quarter panel weather strip removed, inspect for clear seam sealer between the c-pillar and rear quarter panel (Area 1 as seen above).

5 - If seam sealer is not present, or if any gaps are found in the sealer, apply clear flowable seam sealer between the c-pillar and rear quarter panel sheet metal as shown per red line in picture.

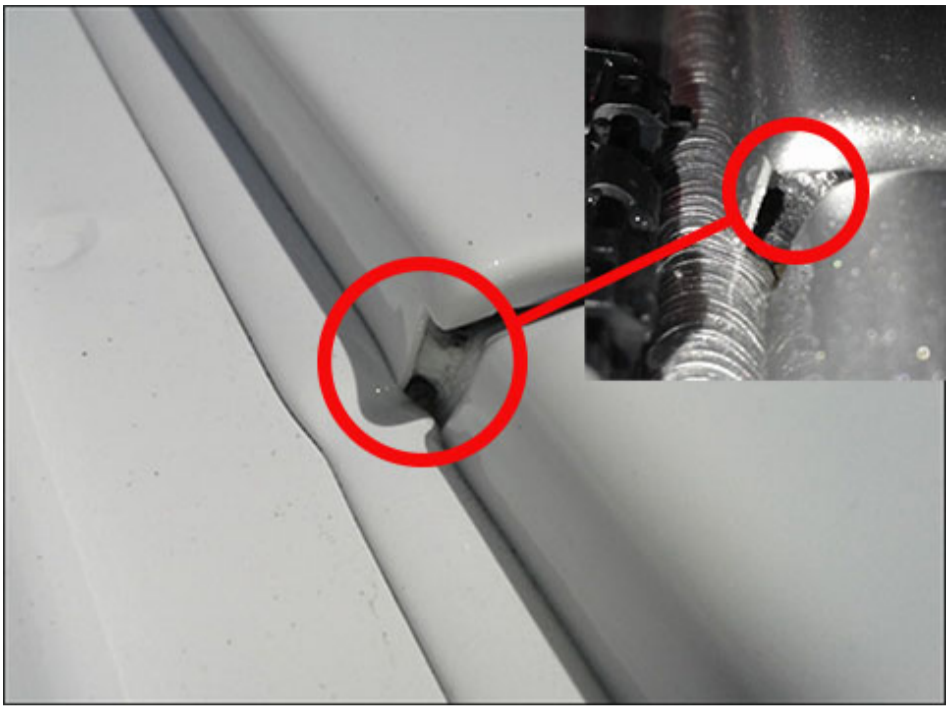
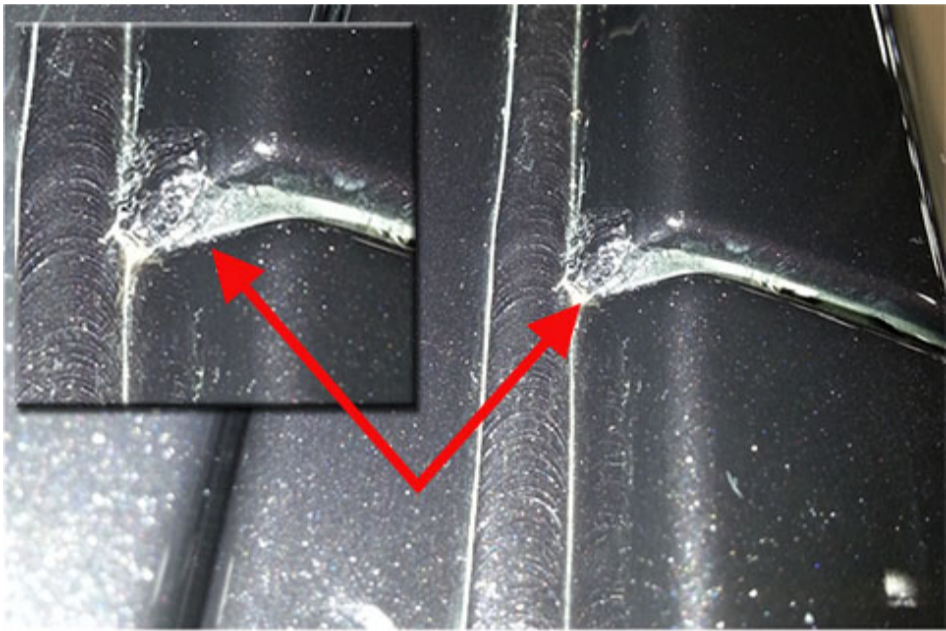
6 - With the roof rail removed on the affected side, inspect existing seam sealer in the area shown; door surround to quarter panel and roof panel (Area 2 as seen above) for skips or pin holes in the sealer.

7 - Fill any voids or pins holes found in the existing seam sealer with clear flowable seam sealer.

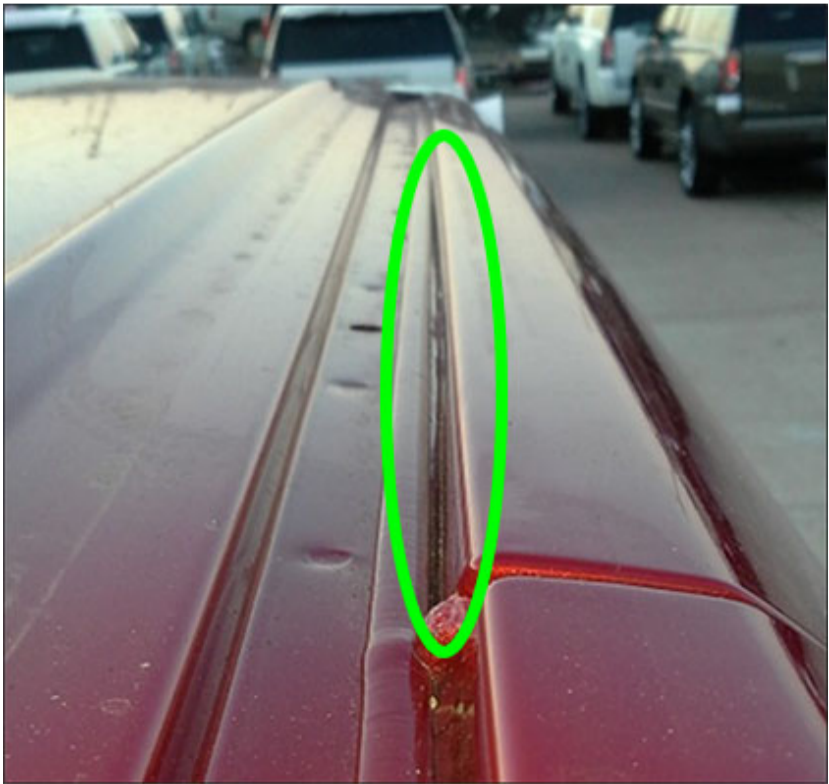
8 - With the roof rail removed on the affected side, inspect existing seam sealer in the area shown; quarter panel to roof panel (Area 3 as seen above) for skips or pull-away along the outboard edge.

9 - Apply clear flowable seam sealer along the rear quarter panel to roof seam as illustrated in picture above.
