Bulletin No.: PIT5659

PIT5659 Driver Side Power Seat Inoperative

Brand:	Model:	Model Years:	VIN:		Engine:	Transmissions:
			from	to		
Chevrolet	Blazer	2019	All	All	All	All

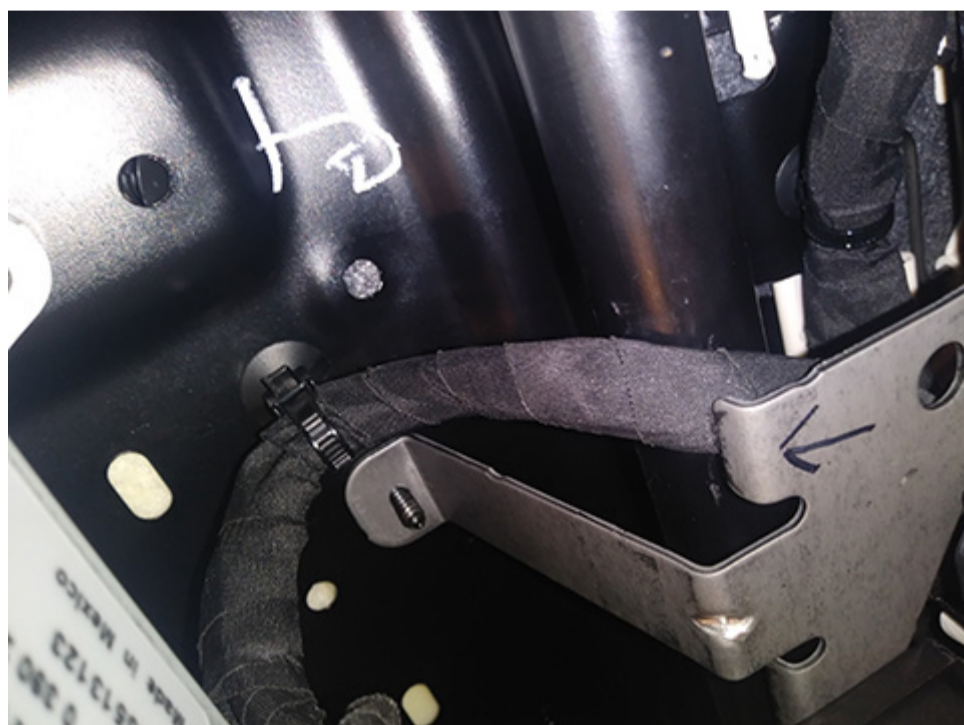
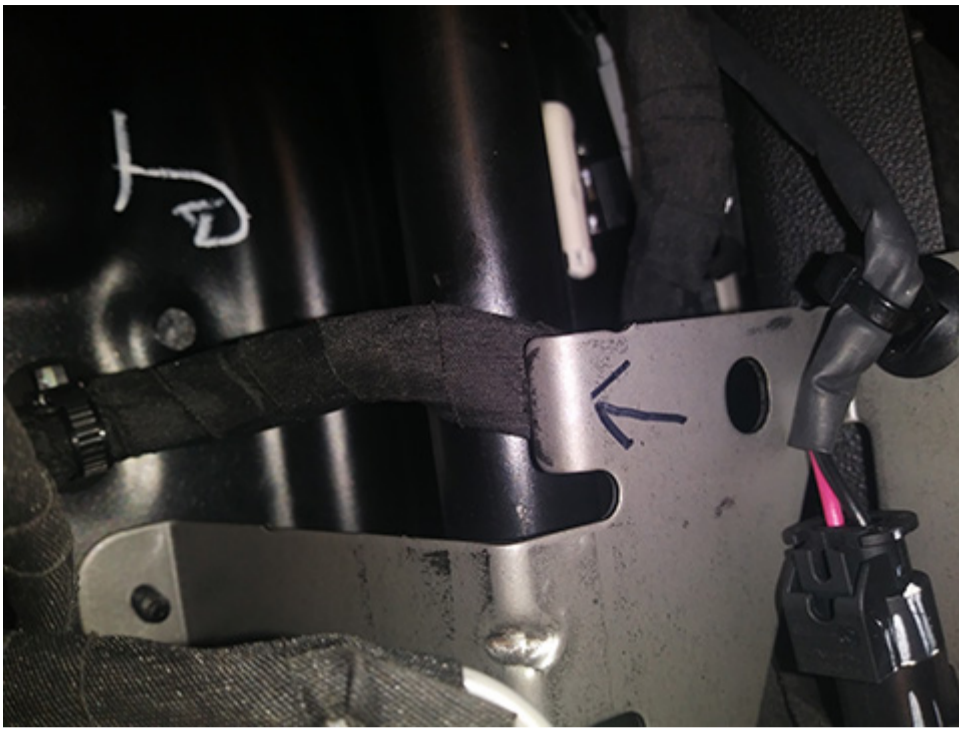
Involved Region or Country	North America
Additional Options (RPO)	AAB
Condition	A vehicle may arrive at the dealer with a complaint that the driver's side power seat will not move at times. Upon checking for codes a B3920 may be found.
Cause	The wire harness may be pinched between the memory seat module bracket and the seat cushion frame tube.

Inspect the seat harness for being improperly routed and pinched between the memory seat module bracket and the seat frame tube.

Repair or replace the seat harness as needed and re-route it so that it will not become pinched or damaged.
