Preliminary Information

PIT5657A Loose Shifter Lever / Poor Shift Actuation from Shift Lever / Shift to Park Message / Dead Battery

Models

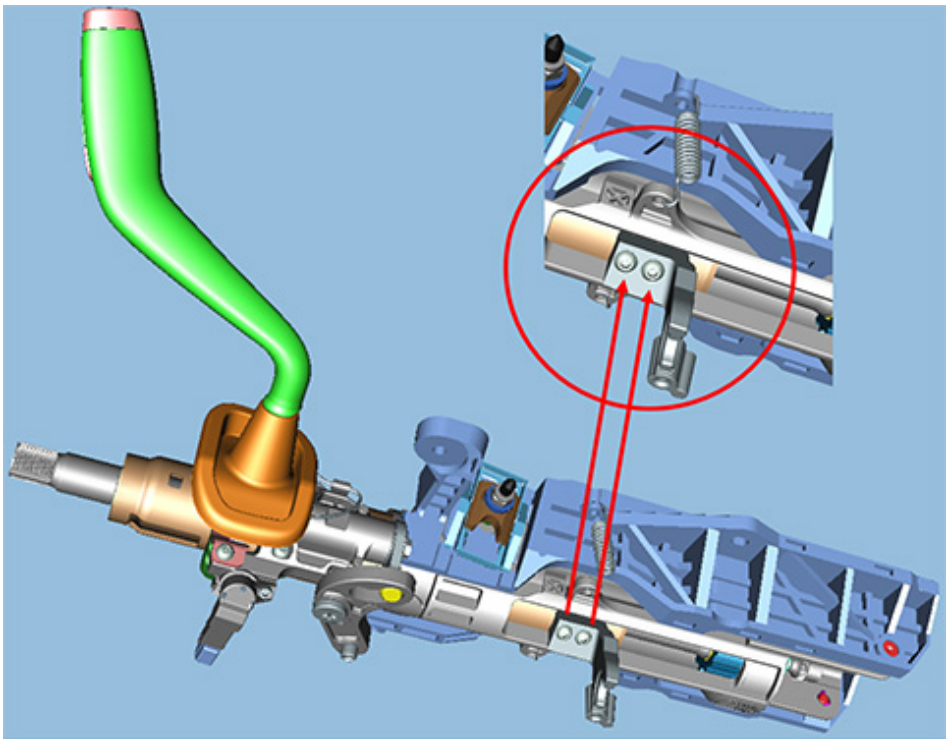
Involved Region or Country	North America
Condition	Some customers may comment of a loose shifter lever, poor shift actuation from the shift handle, and/or unable to shift to park. If the shifter will not go into park, the ignition will not turn off completely, which could cause a dead battery. Also, a "Shift to Park" message will be displayed on the DIC.
Cause	This concern could be caused by the shift cable bracket attaching bolts being loose, see picture below.

Note: Do NOT tighten these bolts, they are not serviceable.

Inspect the shift cable bracket attaching bolts for being loose. If the bolts are found to be loose, replace the steering column assembly. Do NOT tighten or replace these bolts, they are not serviceable.
