Bulletin No.: PIT5665
Published date: 03/14/2019

PIT5665 Poor Remote Keyless Entry (RKE) Fob or Passive Unlocking Range

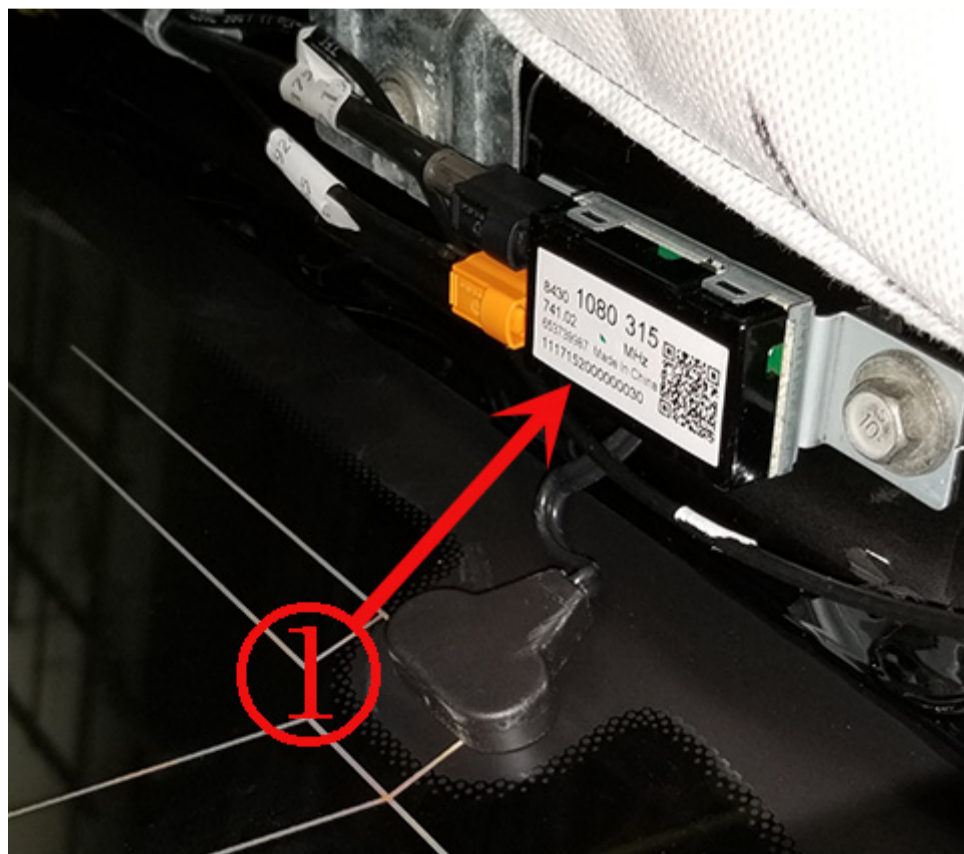
Involved Region or Country	North America
Condition	Some customers may comment on poor remote keyless entry (RKE) range (less than 20 feet.) Some customers may comment that the RKE fob must be held next to the driver's door handle before the doors will unlock when passively attempting to unlock the door.
Cause	Engineering is currently investigating this concern.

Replacing the Radio Antenna Amplifier (1) may correct the range concern.
