### PIP5319F Rattle From the Turbocharger on Cold Start

Brand:	Model:	Model Years:	VIN:		Engine:	Transmissions:
			from	to		
Cadillac	CTS-V Sport	2014 - 2016	All	All	LF3 Turbo	All
Cadillac	XTS	2014 - 2016	All	All	LF3 Turbo	All

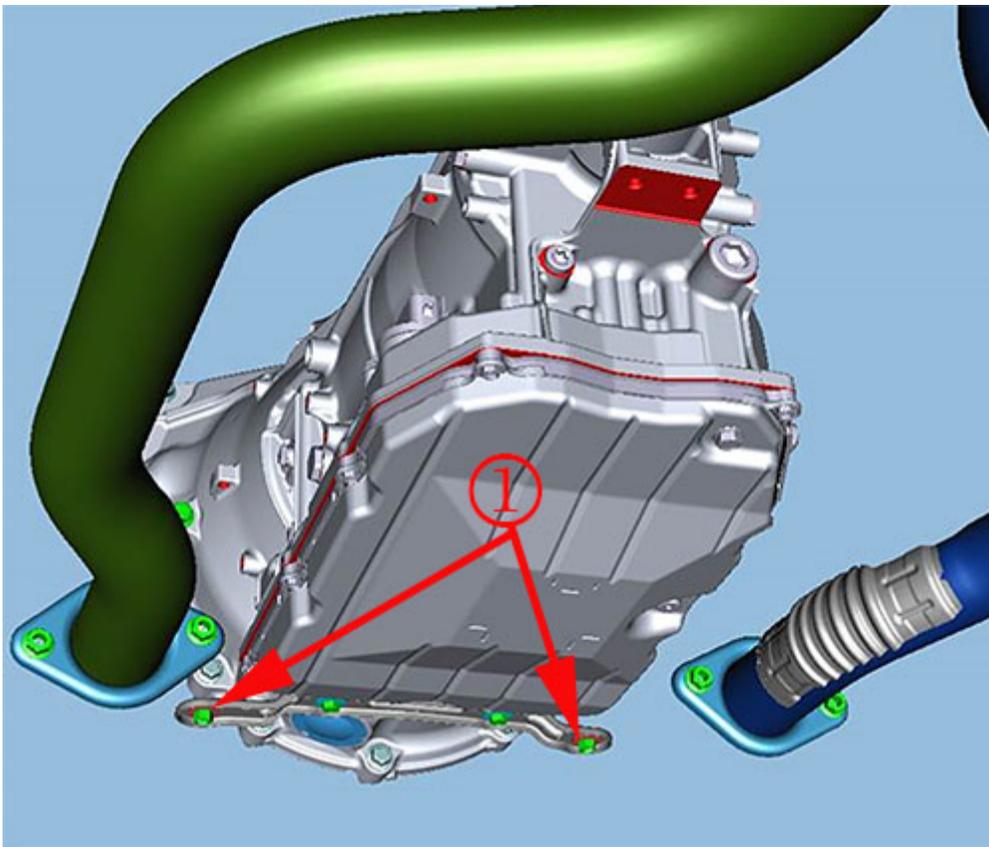
**Inspect the M8 nuts noted in the picture that secure the catalytic converters to the exhaust bracket.**

**Over time during normal operating conditions these nuts can lose torque and cause a rattle that sounds like it is coming from the turbocharger.**

**If technician finds the M8 nuts are loose it will be necessary to replace them with new torque prevailing nuts, P/N 11546441 LF3 (2 nuts).**
