Preliminary Information

PIT5379E Diagnostic Tips - Unwanted Content Theft Alarm Sounds

Brand:	Model:	Model Years:	VIN:		Engine:	Transmissions:
			from	to		
Cadillac	Escalade	2015 - 2019	All	All	All	All
Chevrolet	Suburban	2015 - 2019	All	All	All	All
Chevrolet	Tahoe	2015 - 2019	All	All	All	All
GMC	Yukon	2015 - 2019	All	All	All	All

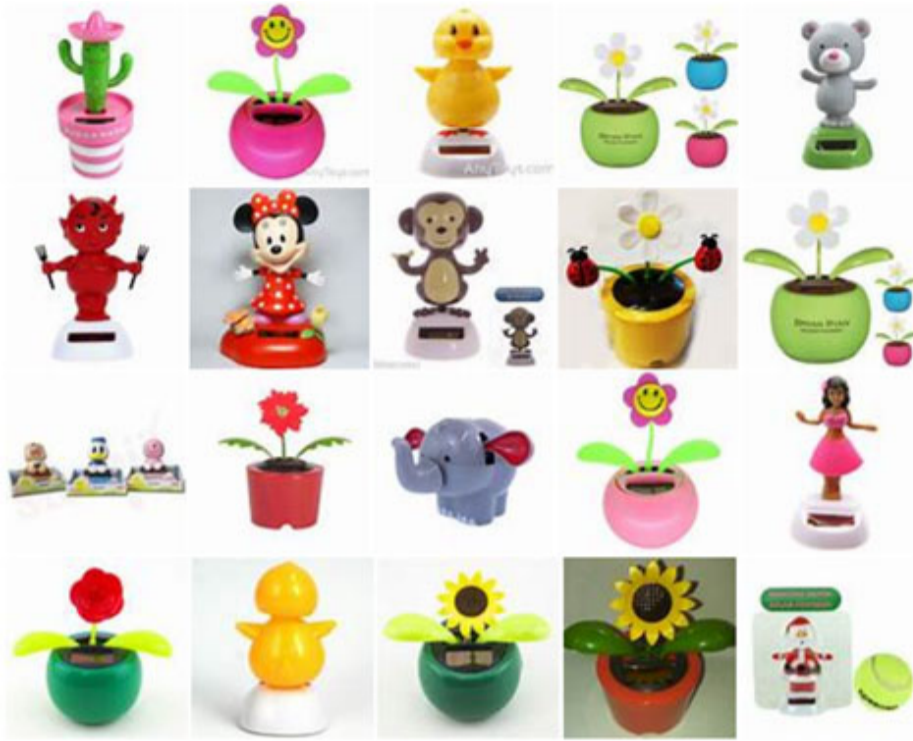
1. Intrusion- Located in the over-head console are ultrasonic intrusion sensors. These sensors are used to detect motion inside the vehicle. There have been reports of flying insects, pets, items hanging from the rear view mirror, solar powered dancing characters (examples below), etc. moving inside the vehicle and triggering the alarm. These items will have to be removed and the system retested before performing any additional diagnostics.
