Preliminary Information

PIP5541A Shudder Or Vibration From The Transmission

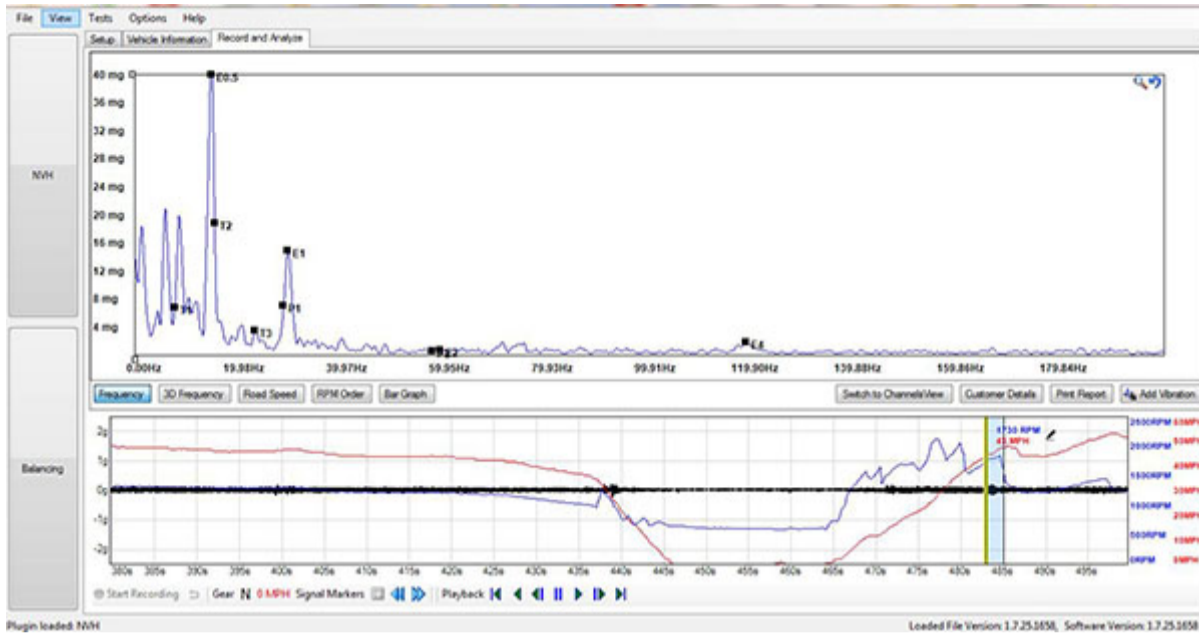
If the Pico file shows E0.5 being the dominant disturbance as shown below the concern is not torque converter clutch shudder and may be an engine performance concern.
