GROUP CLI	MODEL 2019MY Niro (DE P/HEV)
	NUMBER 044	DATE March 2019
TECHNICAL SERVICE BULLETIN		
SUBJECT: SERVICE ACTION: A/C REFRIGERANT OVERFILL (SA372)

SERVICE ACTION: AC REFRIGERANT OVERFILL (SA372)

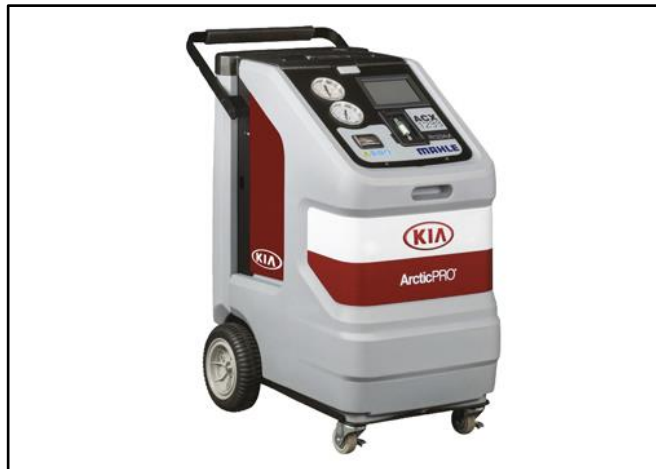
This bulletin provides the procedure to recover and recharge the air conditioning system on certain 2019MY Niro Hybrid (DE HEV) and Niro Plug-in Hybrid (DE PHEV) vehicles, produced from July 9, 2018 through December 21, 2018, which may experience poor air conditioning performance due to a possible overfill of refrigerant. Follow the procedure in this bulletin to recover and recharge the air conditioning system with the proper amount. Kia is requesting the completion of this Service Action on all affected vehicles including dealer stock, prior to delivery. Before conducting the procedure, verify that the vehicle is included in the list of affected VINs.
