**Panoramic Roof Water Management**

Revision	Release Date	Changes
0	March 11, 2019	Original document

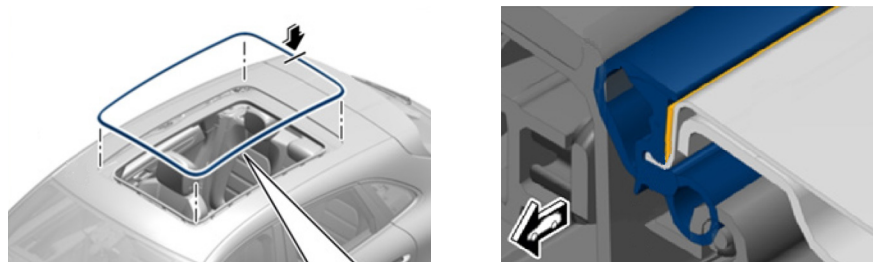
If enough water has made it into the vehicle to be noticed by the customer and cause damage, the first line of defense has definitely been breached.

- The external seal(s) fit and condition should be carefully inspected and adjusted, or replaced as necessary.
- Make sure the glass panels and frame are centered in the body opening to get the best sealing performance.

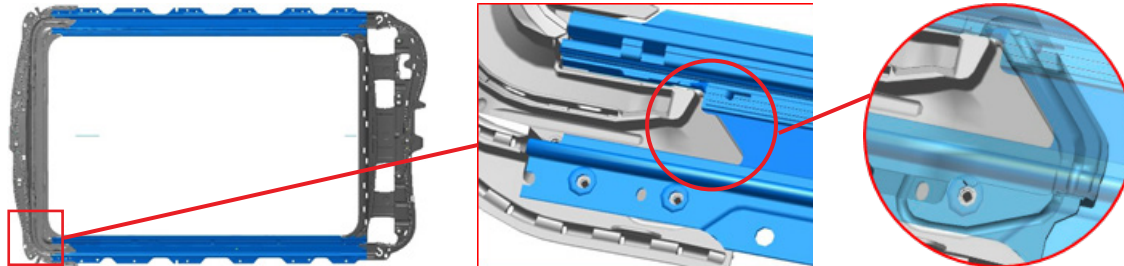
The second line of defense needs to be inspected to see if the frame connections are leaking. A bead of butyl sealant is used at each corner to seal the ends of the frame to the guide rails of the frame.

- If a leak is found at a corner(s), the frame must be replaced.
- NOTE: A recent analysis found that 2/3 of the frames replaced on a particular vehicle with this system did not have the outside seal replaced.
  - o This could continue to allow water in after the new frame is replaced.
  - o Please carefully evaluate the seal condition and fit as mentioned above.
