Complaint - Cylinder Head Cover Near the Injector Holes Leaking: Subsequent work on cylinder head (180/18)

Model Line: **Cayenne (9YA) — LK2/LK3**

Model Year: **As of 2017 up to 2019**

Subject: **Cylinder head cover**

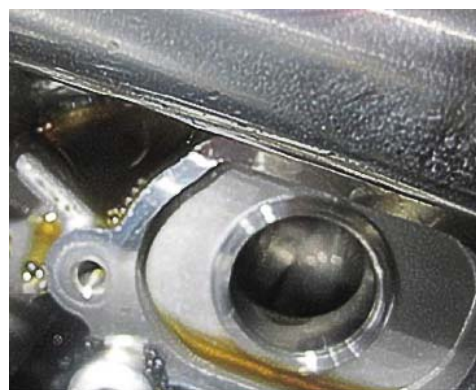
- O-ring on valve lift adjustment solenoid hydraulic valve is responsible for the leak(s).
- Clean the engine compartment and replace the affected solenoid hydraulic valve(s) with O-rings.
- If the insulation on the top of the cylinder head cover is already soaked with oil, this must be replaced too.
- With ⇒ 3 continue.

Fault type 1: Valve lift adjustment solenoid hydraulic valve leaking

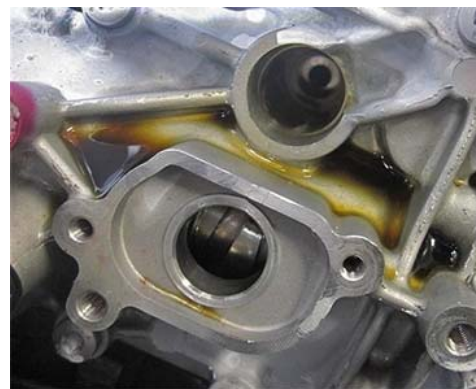
2.3.1 Oil must have collected in the vicinity of the injector of the affected cylinder and the insulation on the bottom of the cylinder head cover should be fully soaked.

Fault type 2: Cylinder head cover leaking

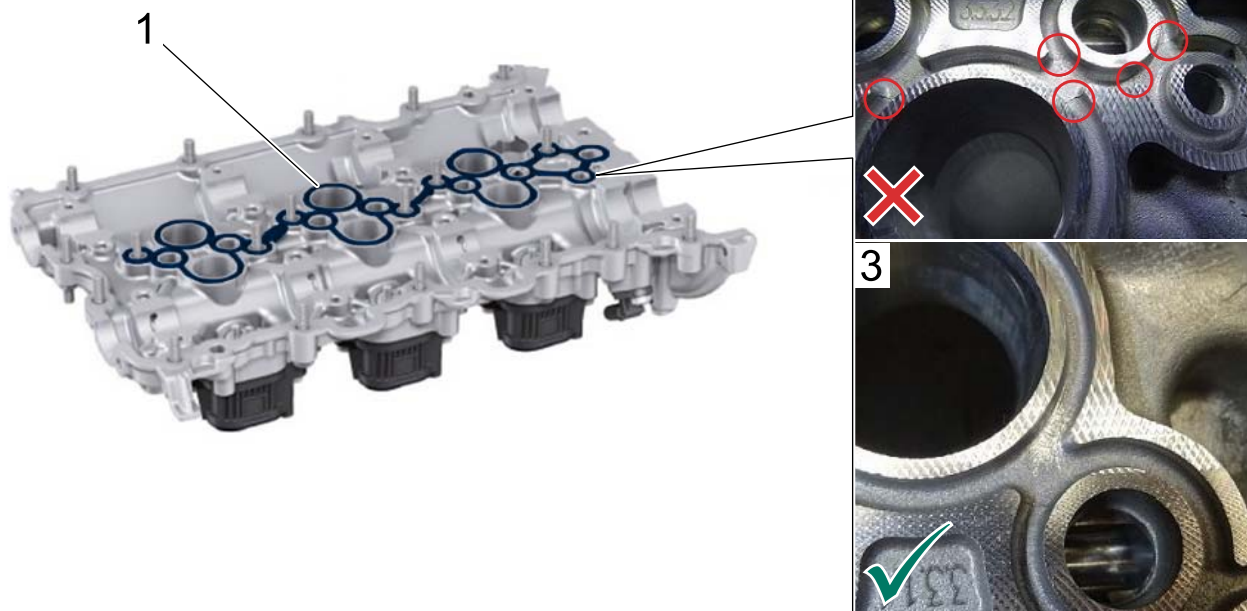
- Due to a batch error in the casting procedure there may be cast residue in the cylinder head cover sealing groove.
- This cast residue may cause the injector holes to leak.

Cylinder head cover sealing groove

2.6 Check the sealing groove (⇒ *Cylinder head cover sealing groove -1-*) of the cylinder head cover visually. Be particularly meticulous when doing this especially in the vicinity of the affected cylinder.

2.7 Carefully remove any cast residue (⇒ *Cylinder head cover sealing groove -2-*) using a small flat screwdriver, ensuring that the sealing groove is not damaged. There must be no more cast residue in the sealing groove after machining (⇒ *Cylinder head cover sealing groove -3-*).
