**Complaint - Cylinder Head Cover Near the Injector Holes Leaking: Subsequent work on cylinder head (180/18)**

Model Line: **Panamera (971) — LK2/LK3**

Model Year: **As of 2017 up to 2019**

Information: **Complaint about injector hole leaks**

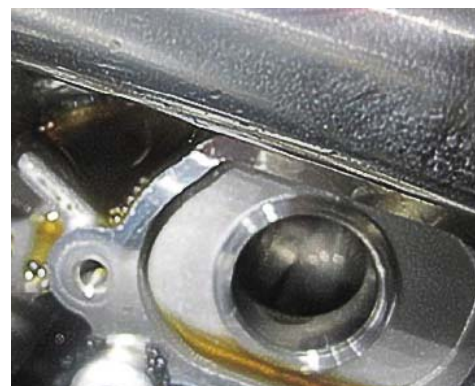
- 1.1 To remove engine cover (design cover), see ⇒ *Workshop Manual '108319 Removing and installing engine cover (design cover) (V6 Turbo)'*.
- 1.2 To remove turbocharger heat shield, see ⇒ *Workshop Manual '261219 Removing and installing turbocharger heat shield (V6 Turbo)'*.
- 1.3 Look to see whether both cylinder head covers have leaks, then continue on the relevant cylinder head with ⇒ 1.4.
- 1.4 Remove insulation on top of the cylinder head cover.
- 1.5 To remove valve lift adjustment solenoid hydraulic valves, see ⇒ *Workshop Manual '155519 Removing and installing valve lift adjustment solenoid hydraulic valve (V6 turbo)'*.
- 1.6 Look and see whether there is a large quantity of oil under the valve lift adjustment solenoid hydraulic valve, see ⇒ *Fault type 1: Valve lift adjustment solenoid hydraulic leaking*.

*Fault type 1: Valve lift adjustment solenoid hydraulic leaking*

- O-ring on valve lift adjustment solenoid hydraulic valve is responsible for the leak(s).
- Clean the engine compartment and replace the affected solenoid hydraulic valve(s) with O-rings.
- If the insulation on the top of the cylinder head cover is already soaked with oil, this must be replaced too.
- Continue with ⇒ 3.

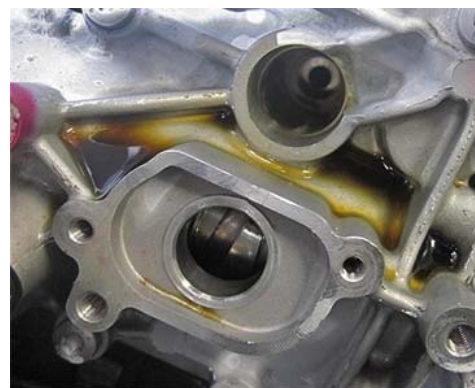
- Due to a batch error in the casting procedure there may be cast residue in the cylinder head cover sealing groove.
- This cast residue may cause the injector holes to leak.

2.3.1 Oil must have collected in the vicinity of the injector of the affected cylinder and the insulation on the bottom of the cylinder head cover should be fully soaked.

⇒ *Fault type 2: Cylinder head cover leaking*

*Fault type 2: Cylinder head cover leaking*

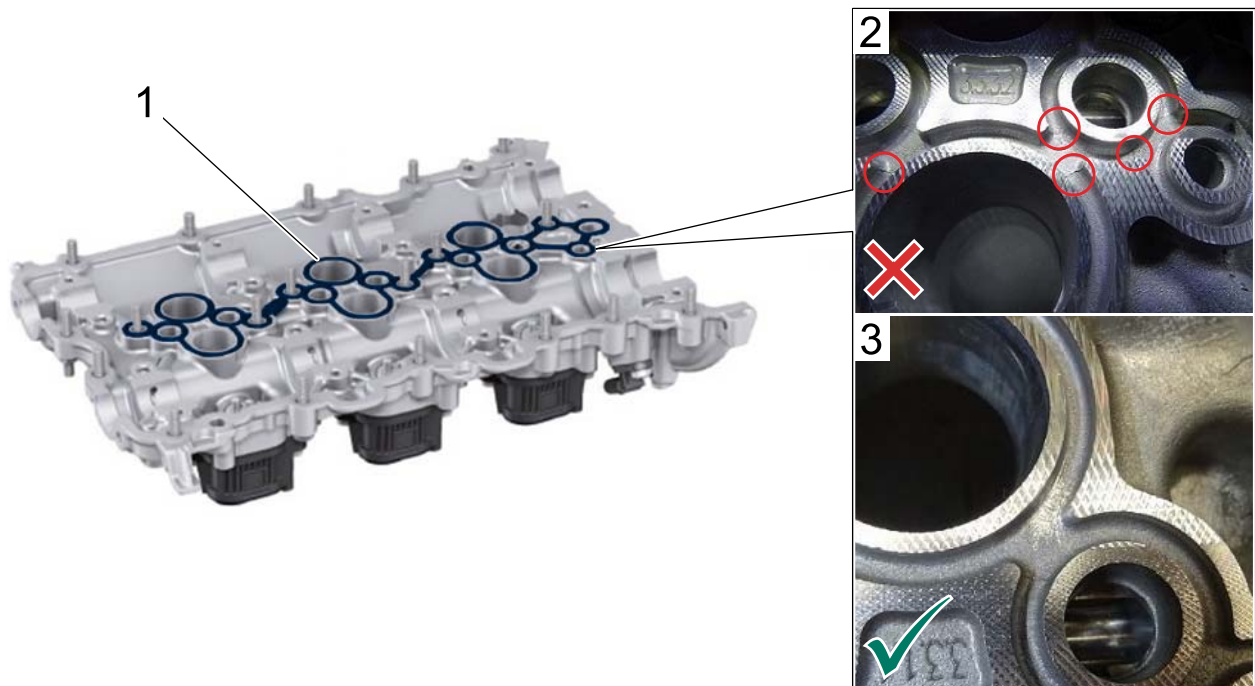
2.6 Check the sealing groove (⇒ *Cylinder head cover sealing groove -1-*) of the cylinder head cover visually. Be particularly meticulous when doing this especially in the vicinity of the affected cylinder.

*Cylinder head cover sealing groove*

2.7 Carefully remove any cast residue (⇒ *Cylinder head cover sealing groove -2-*) using a **small flat screwdriver, ensuring that the sealing groove is not damaged**. There must be no more cast residue in the sealing groove after machining (⇒ *Cylinder head cover sealing groove -3-*).
