Technical Service Bulletin

30 Gearbox leak on gearbox service opening

30 19 23 2053597/1 January 18, 2019.

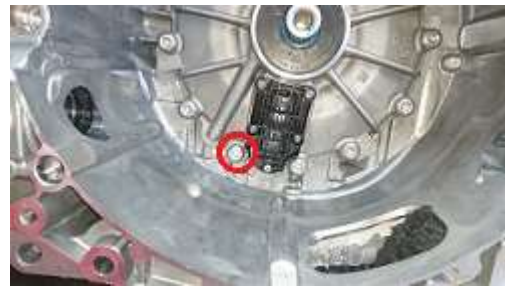
1. Remove the lower bolt of the cover on the passenger's side of the plastic cover (Figure 1 and Figure 2).

Figure 1. Bolt location.

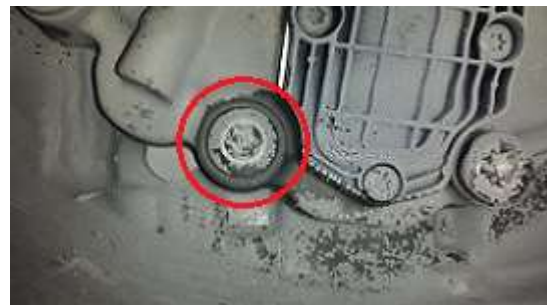
Leaking through the bolt holes of the clutch cover.

Figure 2. Leak location.

1. Remove all bolts of the clutch cover.
2. Clean the bolt holes.
3. Install 12 new bolts for the clutch cover with the part number WHT 002 459 C:

- Tightening torque: 12Nm + 90°.
 - The tightening sequence is a diagonal pattern as described in the repair manual.
4. Reinstall the dual mass flywheel into the transmission per the repair manual.
 5. Reinstall the transmission into the vehicle per the repair manual.
 6. Check and adjust the transmission ATF level.
 7. Road test for proper operation.
