LTB01285NAS1

TECHNICAL BULLETIN

Noise From Front Suspension / Wheel Arch Liner Contacting Front Suspension Stabilizer Bar

MODEL:	MODEL YEAR:	VIN:	ASSEMBLY PLANT:
Discovery Sport (LC)	2015 Onwards	501001 Onwards	Halewood

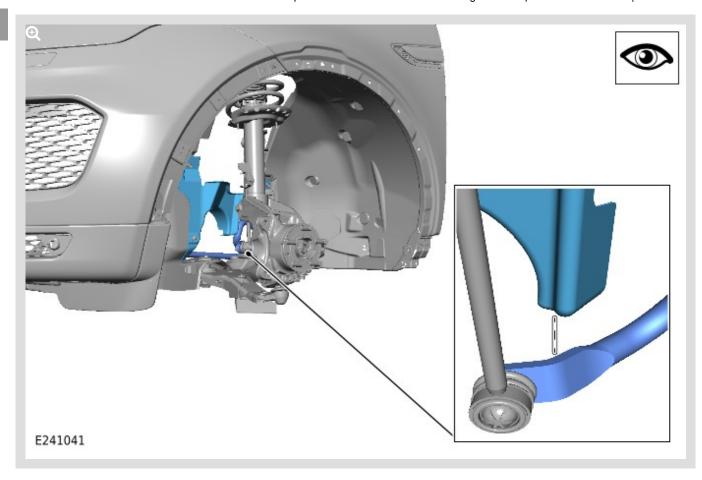
Inspect for evidence of a fouling condition between the front suspension stabilizer bar and the front wheel arch liner center section.

- If a fouling condition is not found, do not continue with this Technical Bulletin as the customers concern does not directly relate to its content.
 - Perform diagnosis per TOPIx Workshop Manual section 204-01:
 Diagnosis and Testing Front Suspension.
- If a fouling condition is found, go to Step 3.
