Latest Vehicle Concern Fixes

Battery Goes Flat due to Coolbox

18MY-19MY – Discovery/Range Rover/ RR Sport

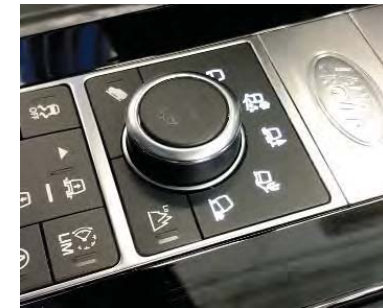
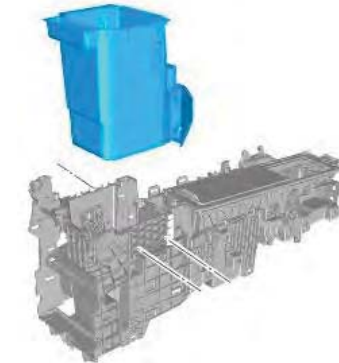
- Intermittently flat battery complaint
- All terrain response switchpack LEDs flashing

- Cool box sending CAN signal that prevents the All Terrain Control Module from going into sleep mode.

- SSM 74232 – Published on 1/16/2019.
 - Replace the Floor Console Cool Box refer to TOPIx workshop manual section 501-12A
- SSM will be updated with end VIN's for all affected models in the near future.
