Technical Service Bulletin

70 Rattle noise in left front dash from head-up display

70 19 67 2044763/3 January 15, 2019. Supersedes Technical Service Bulletin Group 70 number 16-54 dated July 19, 2016 for reasons listed below.

Model(s)	Year	VIN Range	Vehicle-Specific Equipment
A6, A7	2011 - 2017	All	Not Applicable

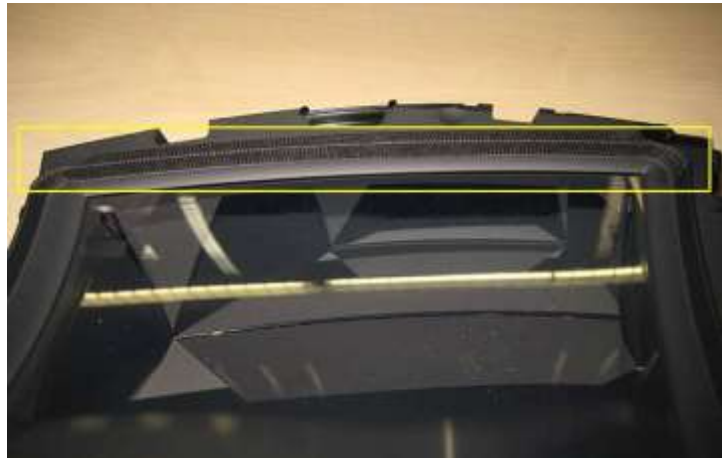
The upper and lower head-up display trim pieces are making contact, which causes the noise.

Figure 1. Placement of textile tape.

Cover the trim of the head-up display with textile tape (part number D 373125A2), as shown (Figure 1). Ensure that the tape completely covers the edge of the trim.
