# Technical Service Bulletin

## 01 MIL on, DTC P030500 stored in ECM

01 19 03 2045909/6 February 12, 2019. Supersedes Technical Service Bulletin Group 01 number 17-34 dated September 1, 2017 for reasons listed below.

Model(s)	Year	VIN Range	Vehicle-Specific Equipment
RS 7, RS 7 performance, and S8 +	2016 - 2017	All	Not Applicable

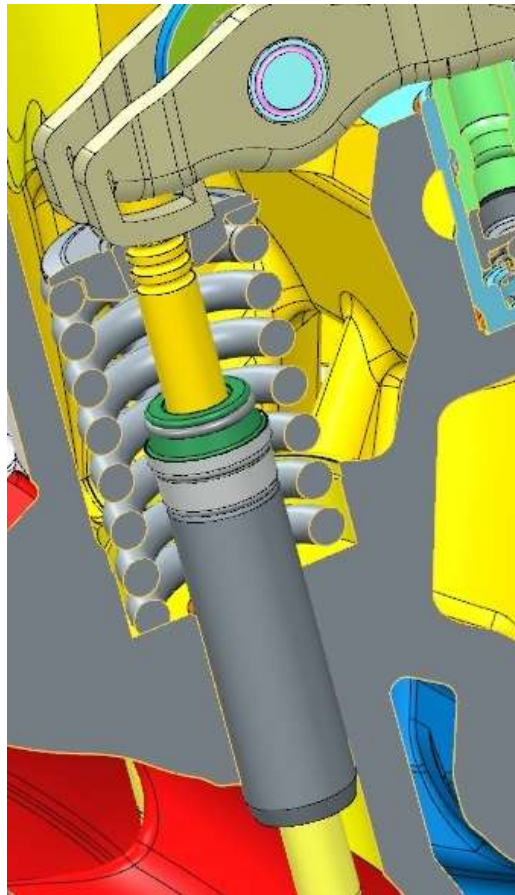
*Figure 1. Before installation.*

1. Follow all instructions in TSB 2011732: *00 Software Version Management (SVM), operating instructions*.
2. Update the ECM, J623 (address word 0001) using the SVM action code as listed in the table below if necessary. No further repairs are necessary after updating the ECM unless the vehicles returns with the same DTC P030500 with the specific ambient conditions listed above, see Step 3-5.
3. If ECM software is up to date, install spring plates under the exhaust valve springs on Bank 2 (cyl 5-8).
4. Before installation on spring plates (Figure 1).

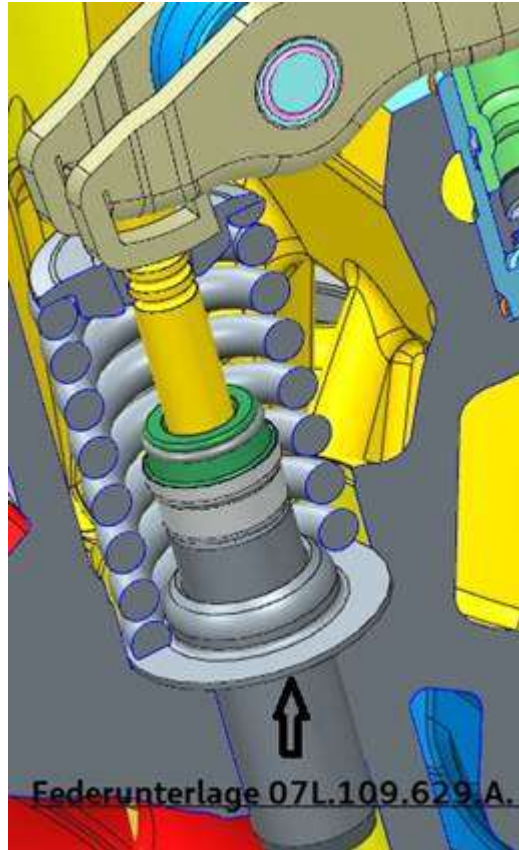
Figure 2. After the part has been installed.

5. After installation of spring plates (Figure 2).
