#### 91 Poor sound reproduction from front bass speakers

91 19 38 2051051/2 February 13, 2019. Supersedes Technical Service Bulletin Group 91 number 18-91 dated April 23, 2018 for reasons listed below.

Model(s)	Year	VIN Range	Vehicle-Specific Equipment
A4, A5	2017 - 2018	All	Not Applicable

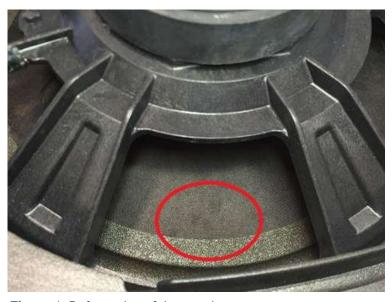
Water coming into contact with the speaker cone causes a deformation of the cone. This deformation allows the voice coil to come into contact with the magnet of the speaker, resulting in unwanted noises (Figure 1).

Figure 1. Deformation of the speaker cone.

2. Replace both front door speaker woofers with part number 8W0035415A.

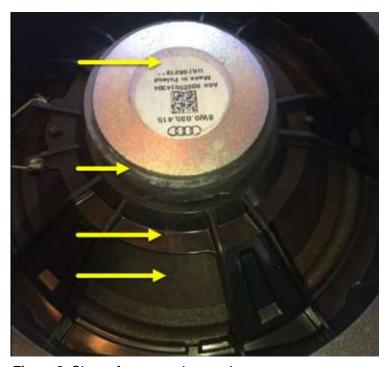
There is water damage to the label. Traces of water are found on the magnet, basket, cone, and surround of the speaker (Figure 2).

Figure 2. Signs of water on the speaker.
