Technical Service Bulletin

91 SOS Warning displayed in instrument cluster, DTC B18BE13 or B18BD13 stored in the telematics control module

91 19 41 2054038/1 February 28, 2019.

Model(s)	Year	VIN Range	Vehicle-Specific Equipment
A6, A7	2019	000001 - 068911	With ConBox

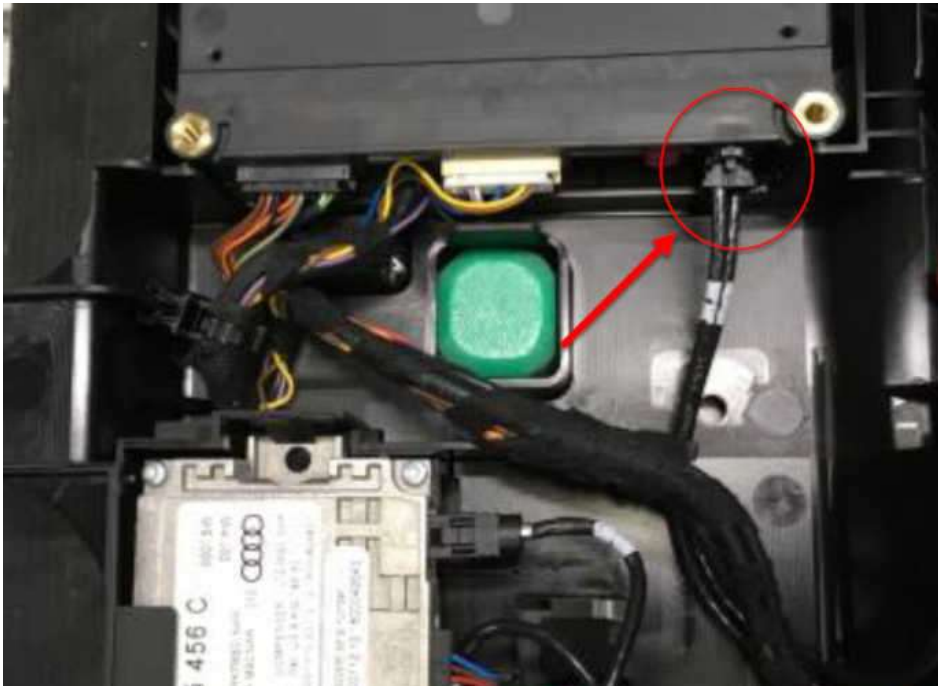
Figure 1. Telematics Control Module (J949) Connector.

- **DTC B18BE13** (Mobile communications antenna 2 for emergency call module/open circuit).
- **DTC B18BD13** (Mobile communications antenna 1 for emergency call module/open circuit).

The 4 pole connector pins might have been widened during the assembly process.

1. Remove the original 4 pole connector including its pins and remove a section of the vehicle's coaxial wiring for the applicable antenna circuit.

Measure the length of coaxial wiring to be removed based off the adapter antenna cable you are using. This will ensure that the removed section is the same length as the adapter antenna cable (000 098 714).

2. Replace the original 4 pole connector and cable with the new connector harness and pins.
3. Before plugging the new 4 pole connector in, make sure that the telematics control module, J949 (address word 0075) is mounted properly in its bracket.

Do not tilt the control module while plugging in the 4 pole connector. Tilting the control module while plugging the connector might damage the new pins.
