# Service Action

## Code: 92D9

<b>Subject</b>	<b>Rain/Light/Humidity Sensor - USA Only</b>
<b>Release Date</b>	February 14, 2019
<b>Affected Vehicles</b>	<b>U.S.A.: Certain 2019 MY Volkswagen Jetta</b> <i>Check Campaigns/Actions screen in Elsa on the day of repair to verify that a VIN qualifies for repair under this action. Elsa is the <u>only</u> valid campaign inquiry &amp; verification source.</i> <ul style="list-style-type: none"><li>✓ Campaign status must show "open."</li><li>✓ If Elsa shows other open action(s), inform your customer so that the work can also be completed at the same time the vehicle is in the workshop for this campaign.</li></ul>
<b>Problem Description</b>	A humidity sensor installed in affected vehicles deactivates the start-stop feature when the Climatronic system is turned on.
<b>Corrective Action</b>	Replace the affected humidity sensor with a rain/light/humidity sensor.
<b>Parts Information</b>	Due to this being a service part, there will be no parts allocation. Parts will be placed on Upper Order Limits. If your dealership is at the weekly Upper Order Limit, please submit the backordered sales document number to <a href="mailto:upperorderlimits@VW.com

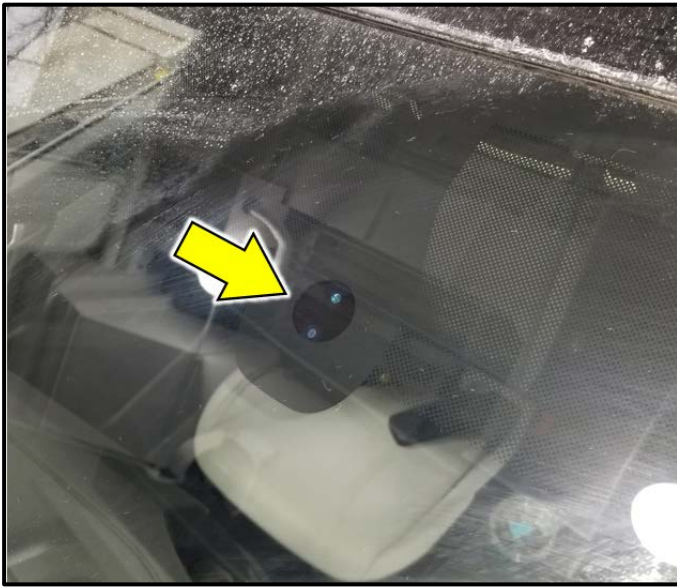
- Even if the sensor is installed correctly, small air bubbles can form between the windshield and the connecting pad.
- The contact surface must be free of bubbles after approximately 10 minutes. If the contact surface is not free of bubbles after 10 minutes, the Rain/Light/Humidity sensor must be removed and installed again.
- Air bubbles between the windshield and the connecting pad cause Rain/Light Recognition Sensor -G397- malfunctions.

#### Inspect for bubbles:
