# Technical Journal

**Click noise from rear body / suspension / shock absorber**

<b>REF NO:</b> TJ 33962.4.0	<b>ISSUING DEPARTMENT:</b> Technical Service	<b>CAR MARKET:</b> United States and Canada	
<b>PARTNER:</b> 3 US 7510 Volvo Car USA		<b>ISSUE DATE:</b> 2019-02-06	<b>STATUS DATE:</b> 2019-02-12
<b>FUNC GROUP:</b> 7612	<b>FUNC DESC:</b> Shock absorber, rear	Page 1 of 3

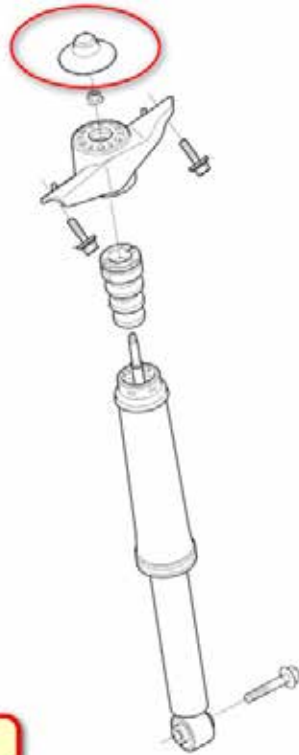
If there is a rattling / clicking / ticking noise while driving, and the noise is likely coming from the rear body or rear suspension, please follow the advice under Service.

- wheel
- outer wheelhouse trim panel
- plastic cap from the shock absorber top mount (see picture 1)
