SERVICE BULLETIN

Classification: EL18-022b	Reference: NTB18-081b	Date: March 19, 2019
------------------------------	--------------------------	-------------------------

2017-2018 PATHFINDER AND 2018 ARMADA; SOFTWARE UPDATES FOR INFOTAINMENT ISSUES

APPLIED VEHICLES: 2017-2018 Pathfinder (R52)
2018 Armada (Y62)

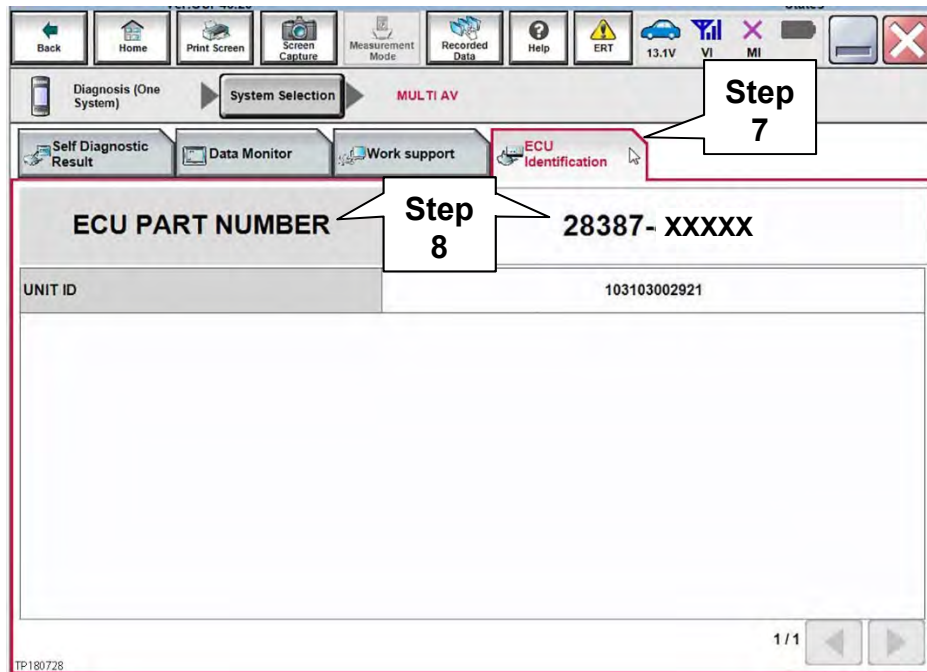
7. Select the **ECU Identification** tab.
8. When the screen in Figure 4 displays, confirm this bulletin applies as follows:
 - a. Write down the **ECU PART NUMBER** on the repair order.
NOTE: This is the current DCU part number (P/N).

- b. Compare the P/N you wrote down to the P/Ns in the **CURRENT DCU PART NUMBER** column in **Table A**, below.
 - If there is a match, continue to the next page, **Update Display Control Unit**.
 - If there is not a match, DCU updating does not apply. Refer to ASIST for further diagnosis.

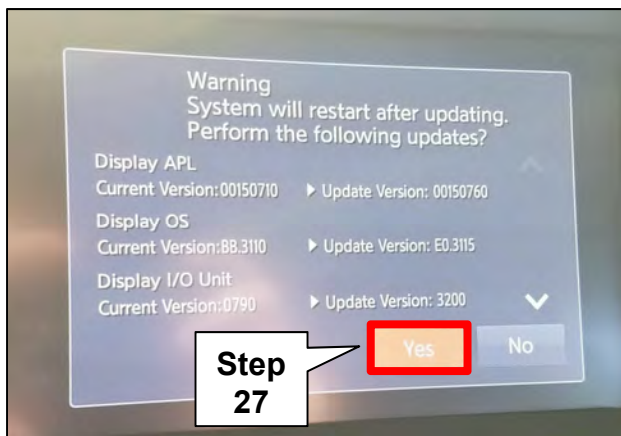
26. Wait approximately 10-30 seconds for the screen in Figure 19 or Figure 20 to appear.
- If the screen shown in Figure 19 appears, then continue to step 27, below.
 - If the screen shown in Figure 20 appears, then no software update is available. Refer to ASIST for further diagnostic information.

27. Select **Yes** to begin the software update.
