## CAMPAIGN BULLETIN Fuel Pump Dealer Inventory

Reference: PC692  
Date: March 29, 2019

Affected Models/Years:	Affected Population:	Dealer Inventory:	SERVICE COMM Activation date:	Stop Sale In Effect
MY2019 Altima (L34) FWD only	NA	111	March 29, 2019	<b>YES</b>

# PC692 - 2019 – ALTIMA (2.5L FWD ONLY) FUEL PUMP LOCK RING INSPECTION

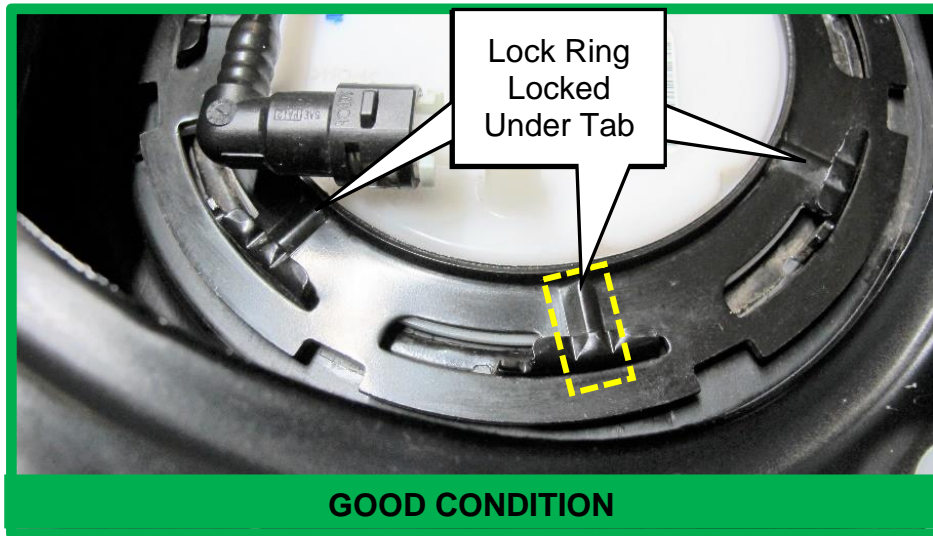
Figure 6

a. If fuel pump lock ring **IS** locked under tab as shown in Figure 6, proceed to REPAIR SECTION, Step 10 (Page 6). If **NOT** properly secured go to next step (b).

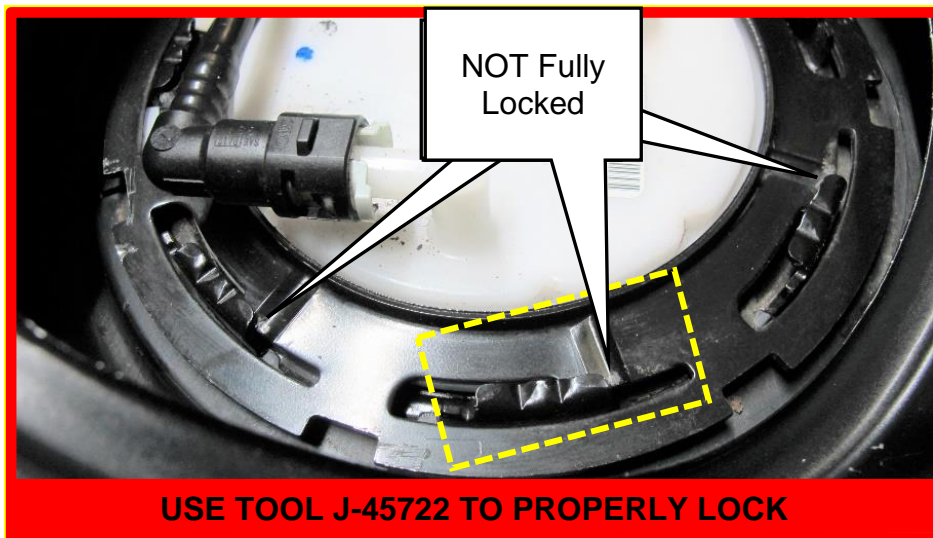
Figure 7

b. If fuel pump lock ring is **NOT** fully locked under tab as shown in Figure 7, proceed to REPAIR SECTION, Step 8 (Page 5) to fully lock the lock ring.

9. Using tool J-45722 (Figure 10), rotate the lock ring clockwise to lock the fuel pump lock ring (Figure 11).
  - a. Verify fuel pump lock ring is locked to the fuel tank (See Figure 6).

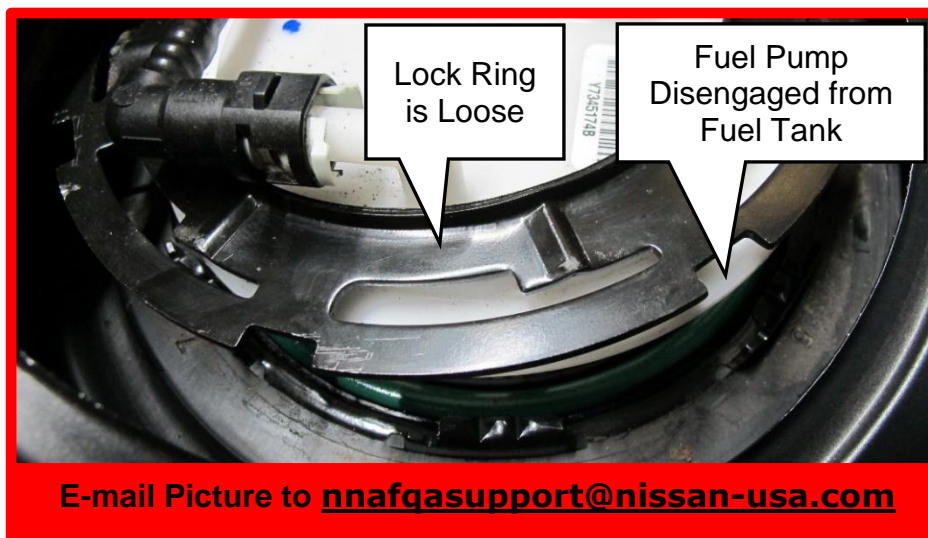
c. If fuel pump is disengaged from fuel tank as shown in Figure 8 below STOP work and **HOLD** vehicle.

- Do not submit a warranty claim
- E-mail a clear picture of the fuel pump disengaged from fuel tank following the instructions below:
