37 Transmission malfunction, DTC P17F600, U008000, and/or U010100 stored in TCM or ECM

37 19 84 2053878/1 February 26, 2019.

| Model(s) | Year | VIN Range | Vehicle-Specific Equipment |
|---|---|---|---|
| A6, A7 | 2019 | 000001 - 050600 | 3.0 TFSI |

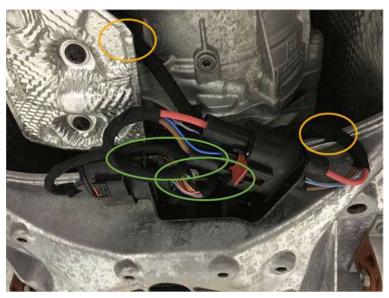
The transmission harness can come in contact with the cross member damaging it.

Figure 1. Common positions for harness damage.

- Inspect for damage to the transmission harness (Figure 1 - 4).
 - Thoroughly inspect the transmission wiring harness for damage.
 - Harness damage can be very subtle. Even a light chafing of the harness wrap can already cause said DTCs.
 - Should no harness damage be found, please contact TAC.

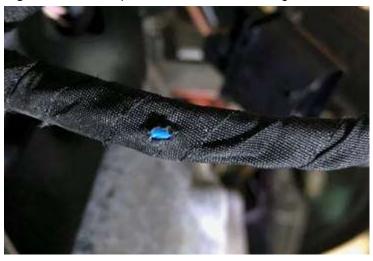
Figure 2. Example of a small rip in the protective tape.

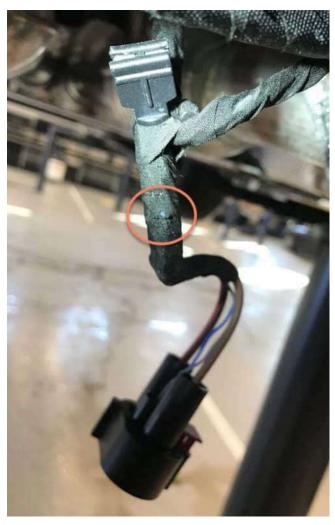
Figure 3. The damage in the harness might be difficult to spot.

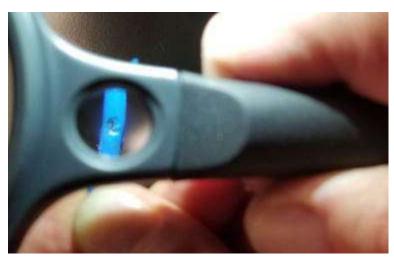
Figure 4. The cause of the DTC may be as a small as a pinhole.

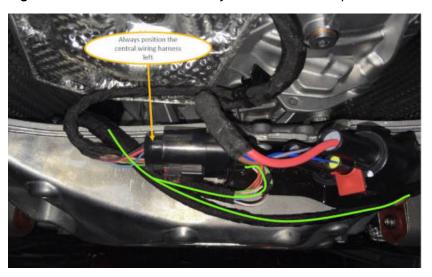
Figure 5. Routing and wrapping of the aft part of the transmission harness.

- 2. Replace and reroute the transmission harness.
 - Remove the old transmission harness in the vehicle.
 - Wrap the exposed wires in the transmission harness as shown in Figure 5.
 - Mount and route the new transmission harness as shown in Figure 6.

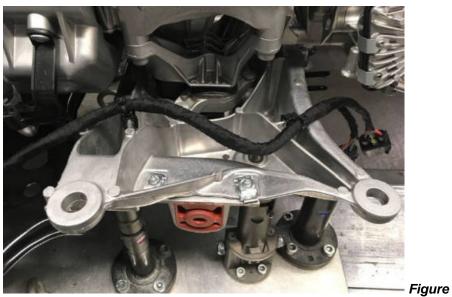
6. Routing and mounting of the transmission harness behind the cross member.

The cross-member is shown dismounted in Figure 6 to show the new mounting points more clearly.For mounting and installation of the new transmission harness, the cross-member does not have to be disassembled.
