# Technical Service Bulletin

## 94 Rear lights do not switch from bumper to hatchgate after closing

94 19 02 2050234/3 February 7, 2019. Supersedes Technical Service Bulletin Group 94 number 18-00 dated July 17, 2018 for reasons listed below.

Model(s)	Year	VIN Range	Vehicle-Specific Equipment
Q5	2018	000001 - 000906	Not Applicable
Q5	2019	All	Not Applicable

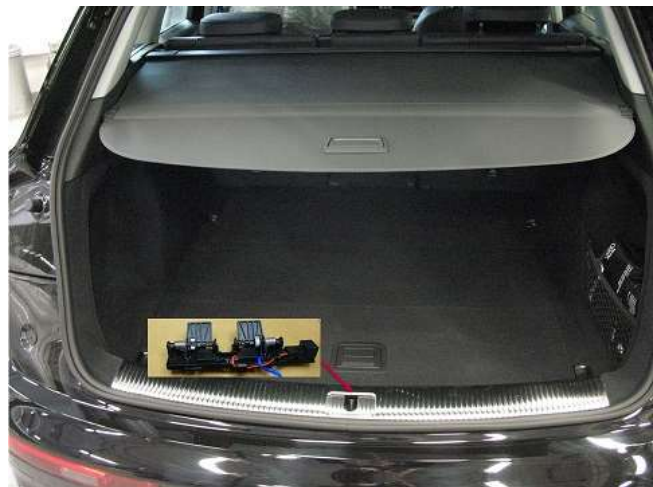
The two micro switches for the reverse light change-over are under the loading sill cover on the rear cross panel and are secured to the striker for the rear lid lock (Figure 1).

1. The paddle on the micro switch was broken due to adjustment of the rear hatch or the striker in production.
2. Dirt can block one/both paddles on the micro switch, which is fastened to the striker of the rear lid (Figure 2).

**Figure 1.** Rear lid closed sensor.

1. Replace the rear lid closed sensor if found broken (Figure 1).
2. In cases where debris is found to be obstructing proper switch activation/deactivation, replace the rear lid closed sensor. The new sensor assembly has been redesigned to shield against the ingress of debris.

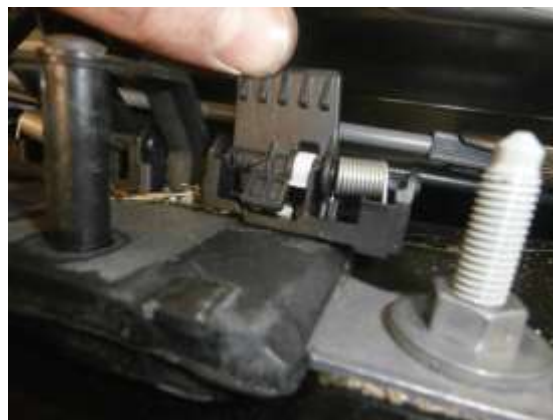
**Figure 2.** Debris trapped in the rear lid closed sensor.
