Technical Service Bulletin

94 Rear lights do not switch from bumper to hatchgate

94 19 03 2047618/3 February 7, 2019. Supersedes Technical Service Bulletin Group 94 number 17-92 dated November 1, 2017 for reasons listed below.

Model(s)	Year	VIN Range	Vehicle-Specific Equipment
Q7	2017	010120 - 999999	Not Applicable
Q7	2018	All	Not Applicable
Q7	2019	000001 - 006497	Not Applicable

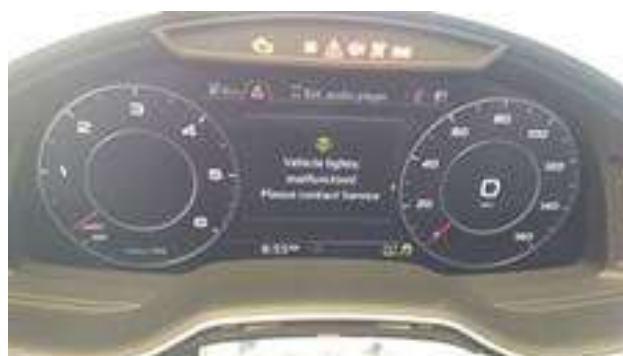
- When the rear lid is closed, the lights in the rear bumper do not switch over to the main lights on the rear lid.
- The error message “Vehicle lights: malfunction! Please contact Service” intermittently appears in the driver information system (Figure 1).
- All of the rear light bulbs are fully functional. None are found to be faulty or incorrect.

Figure 1. Error message.

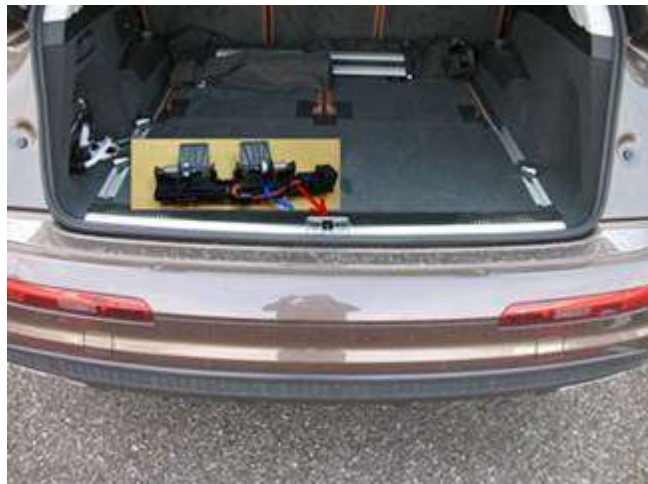
This condition may be caused by incomplete actuation of the rear lid closed sensor G525/G526 due to debris in the switch mechanism (Figure 2).

Figure 2. Rear lid closed sensor.

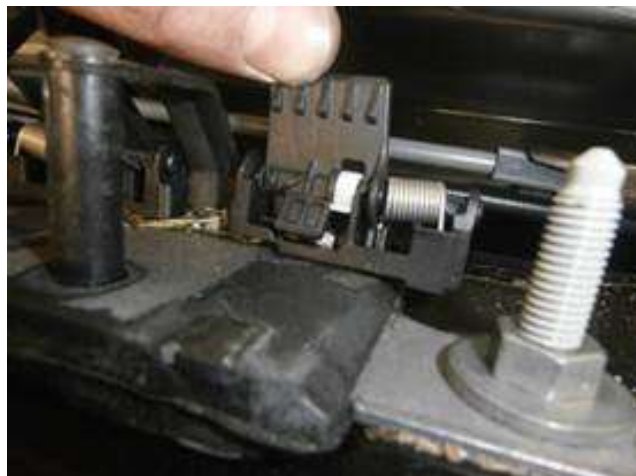
Mounted to the base of the rear lid striker is the G525/G526 rear lid closed sensor. Due to its position, debris that enters the striker housing can get caught in the switch mechanism and cause incomplete switch actuation (Figure 3).

Figure 3. Debris in the rear lid closed sensor.

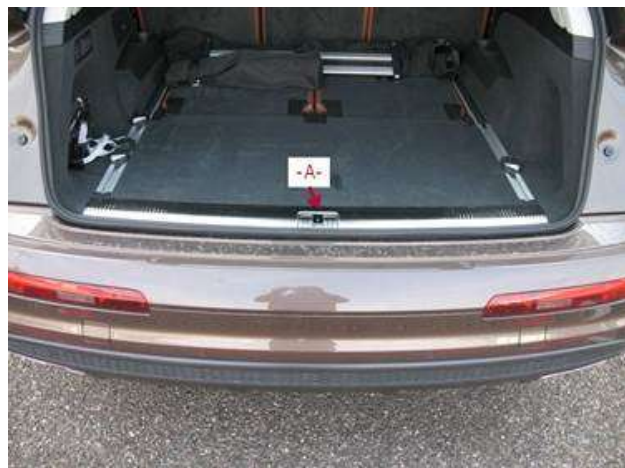
Figure 4. Striker cover opening.

1. Press down the striker cover on the loading sill cover -A- (Figure 4).

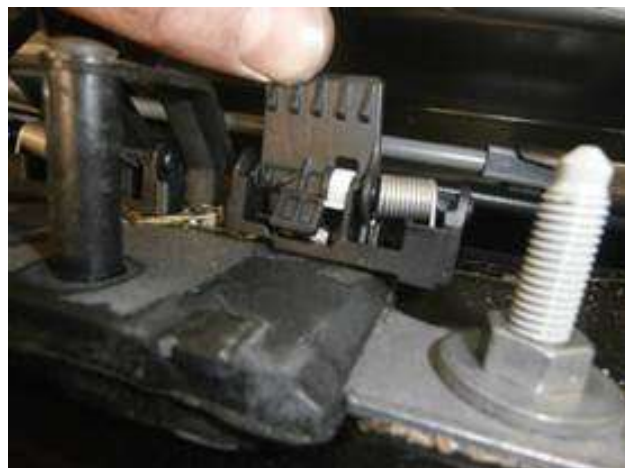
Figure 5. Debris trapped in the rear lid closed sensor.

2. In cases where debris is found to be obstructing proper switch activation/deactivation, replace the rear lid closed sensor. The new sensor assembly has been redesigned to shield against the ingress of debris.
