Technical Tip

Topic	20-19-01TT - Engine Cold Start Concerns
Market area	United States 444 Volkswagen of America, Inc. (6444)
Brand	Volkswagen
Date	February 22, 2019

Engine Cold Start Concerns

Model(s)	Year	Eng. Code	Trans. Code	VIN Range From	VIN Range To
Atlas	2018	3.6L (CDVC)	All	All	All

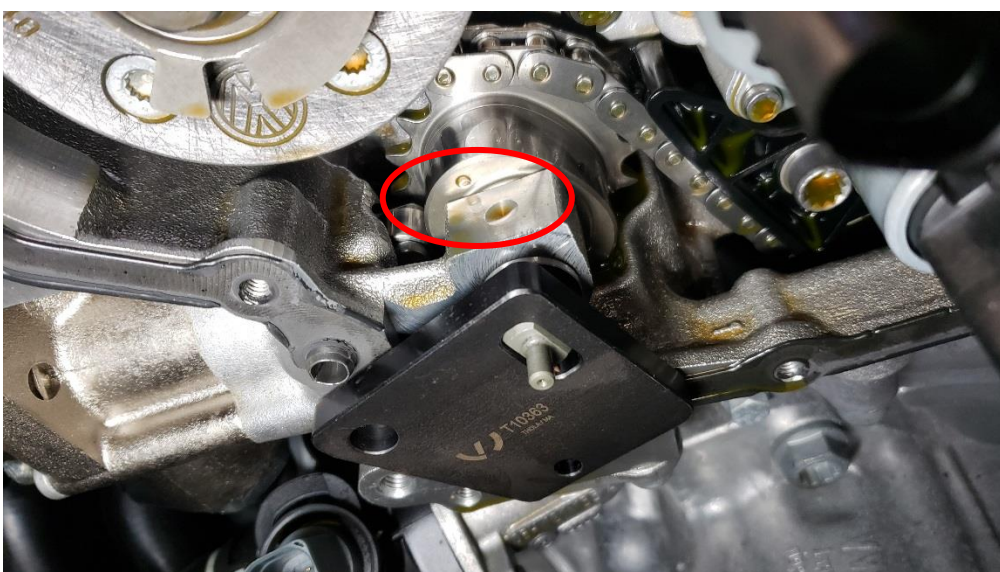
Figure 1.

At cold start the engine RPM fluctuates heavily, the EPC light is ON and the following DTCs are in ECM:

This condition can be caused if the high pressure pump drive socket is not installed in the correct position (Figure1.)

Check that the high pressure pump drive chain sprocket is in the correct position. See repair manual group 15 Cylinder Head, Valvetrain in Elsa.

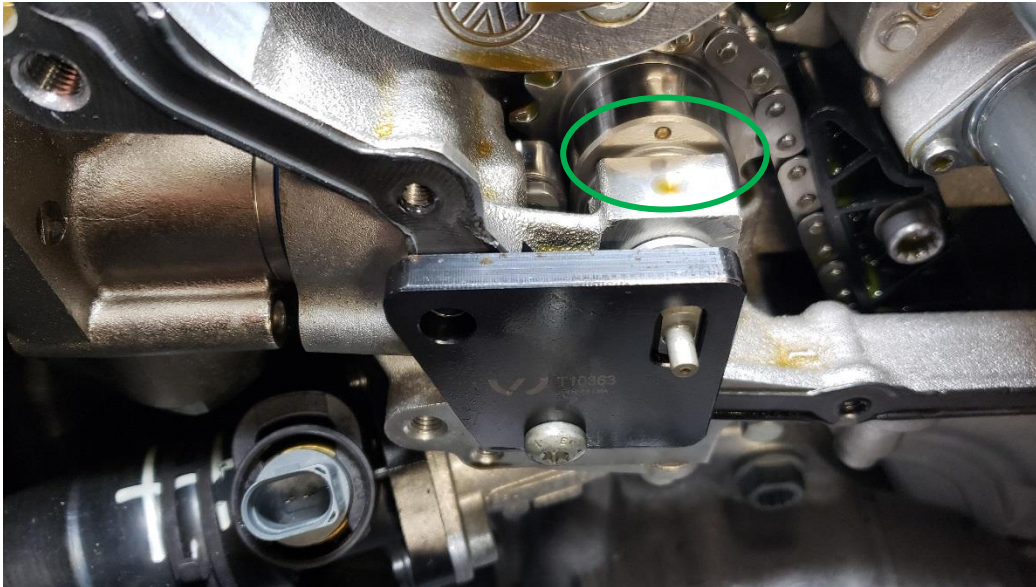
Figure 2.

Figure 2 below is an example of the drive chain sprocket in the correct position.
