20 MIL on, DTC P045600 stored in the ECM

20 19 13 2035073/13 April 11, 2019. Supersedes Technical Service Bulletin Group 20 number 15-54 dated October 29, 2015 for reasons listed below.

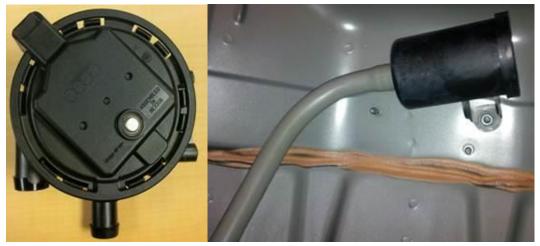
Figure 1. NVLD pressure sensor (left) and NVLD filter (right).

- Ensure that DTC P045600 (EVAP System Leak Detected NVLD (very small leak)) is stored in the engine control module (ECM), J623 (address word 0001). If DTC P045600 is not present, this bulletin does not apply.
- Replace the NVLD pressure sensor G400 and the NVLD filter with the latest part number available (Figure 1).

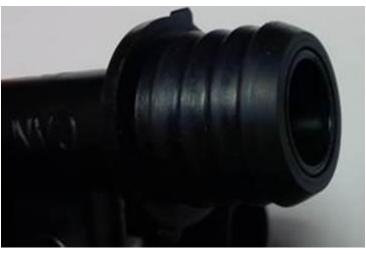
Figure 2. Align the grommet and sensor outer edges.

3. Align the grommet and sensor outer edges (Figure 2).

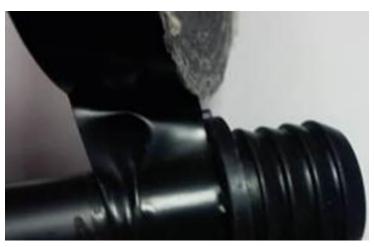
Figure 3. Wrapping vinyl tape behind the grommet.

To aid installation, wrap several (~10) layers of vinyl tape behind the grommet to ensure that it does not slip during installation (Figure 3 and Figure 4).

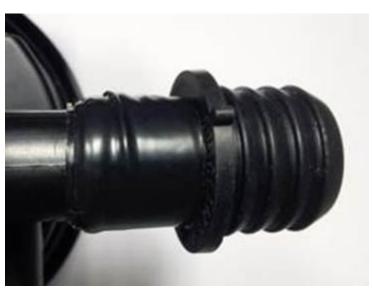
Figure 4. Vinyl layer supporting grommet.

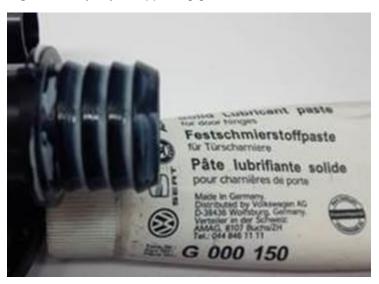
Figure 5. Grease film on the outer surface of the grommet.

5. Apply a small amount of grease to create a film on the outer surface of the grommet before installing the sensor (Figure 5).
